OUR LADY OF THE HOLYLAND PARISH

EXISTING FACILITIES CONDITIONS REPORT

DECEMBER 1, 2023

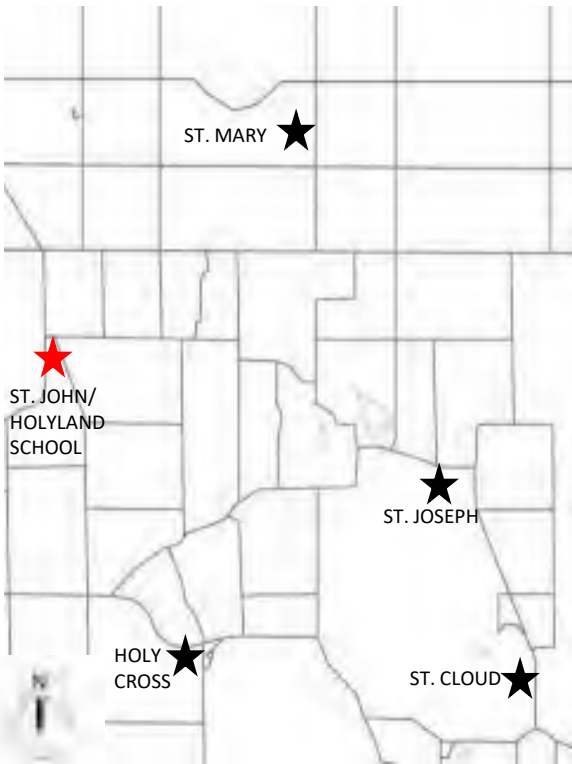
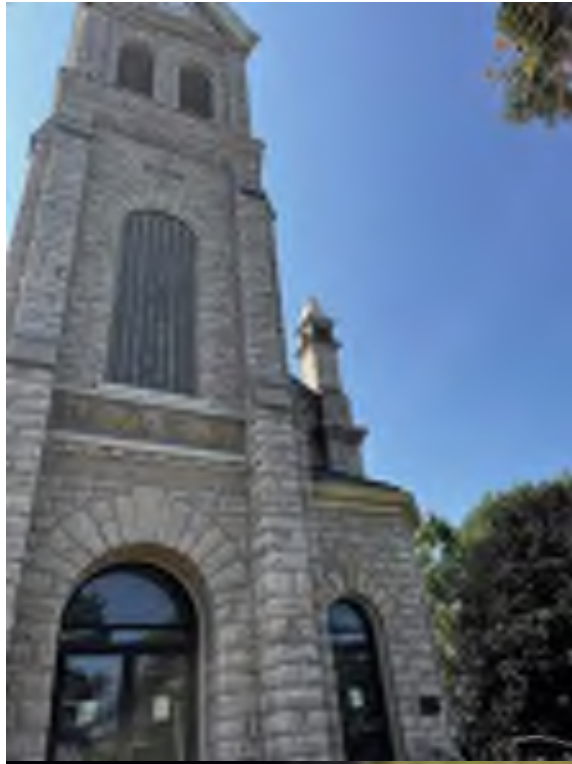
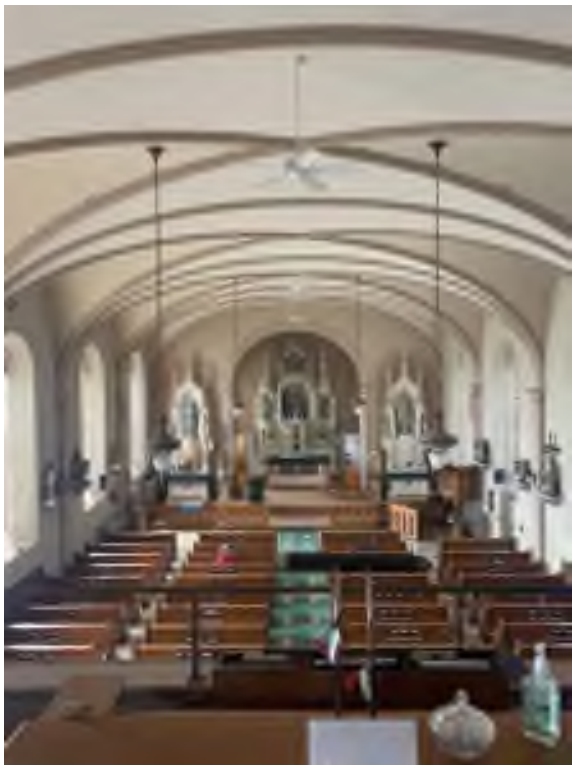
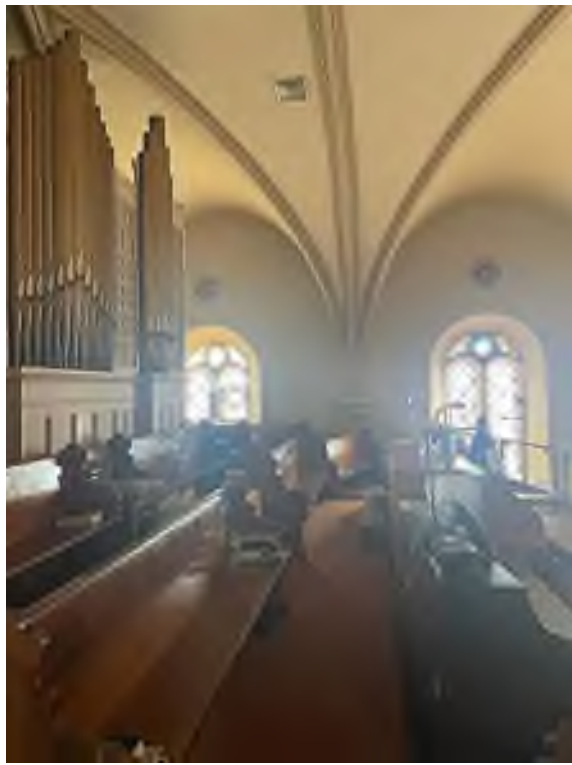
ROOF AGE:	Unknown (Original)
ROOF TYPE:	Slate Tile (Assumed Asbestos)
CONDITION:	Moderate
RECENT REPAIRS:	Wall flashing above vestibule
RECOMMENDED REPAIRS:	Additional flashing repairs needed in same area as listed under recent repairs
REMAINING LIFE:	5-7 Years

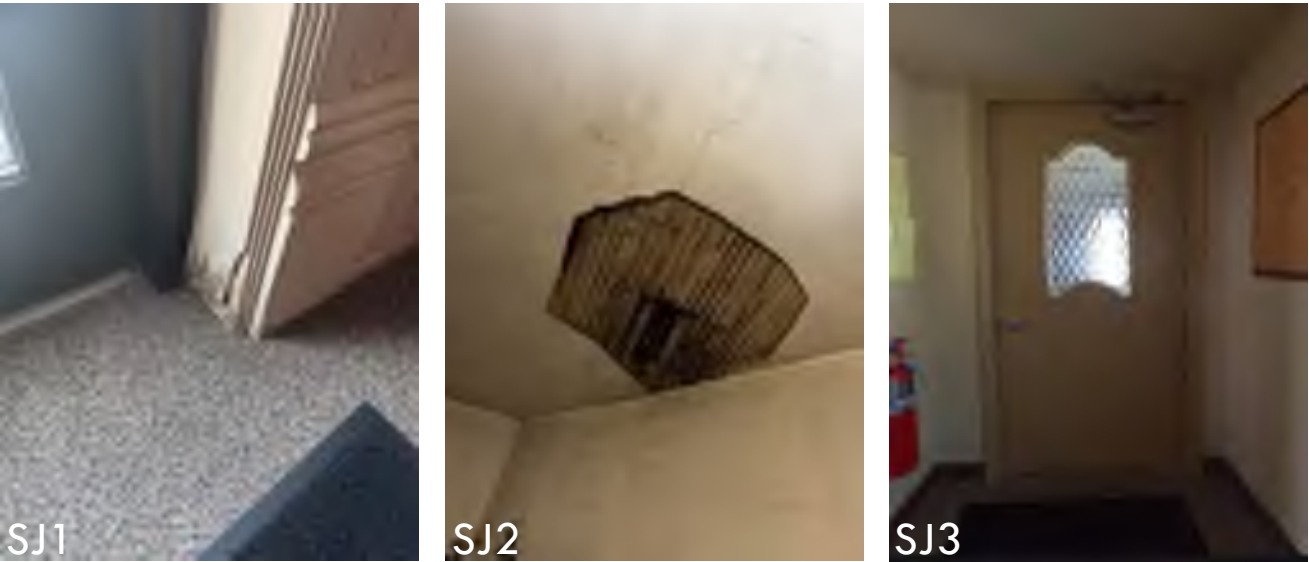
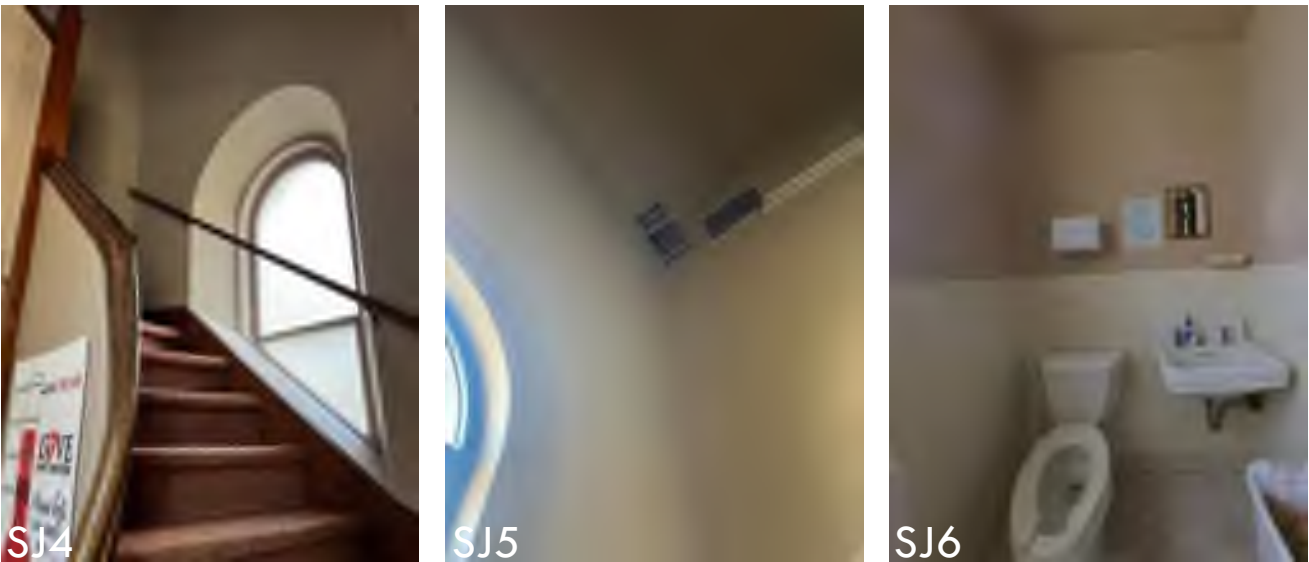
- SJ1 – Rotting in wood door trim.
- SJ2 – Cracking, missing plaster and water damage in both mezzanines.
- SJ3 – Doors in the vestibule are too close together for doors in a series. Door hardware is not compliant for egress.
- SJ4 – No ADA access to mezzanine, railings and guardrails are not compliant.
- SJ5 – Leak in ceiling, fixed bucket is currently in place that requires changing.
- SJ6 – Restroom is not ADA compliant, not enough fixtures for occupancy type.

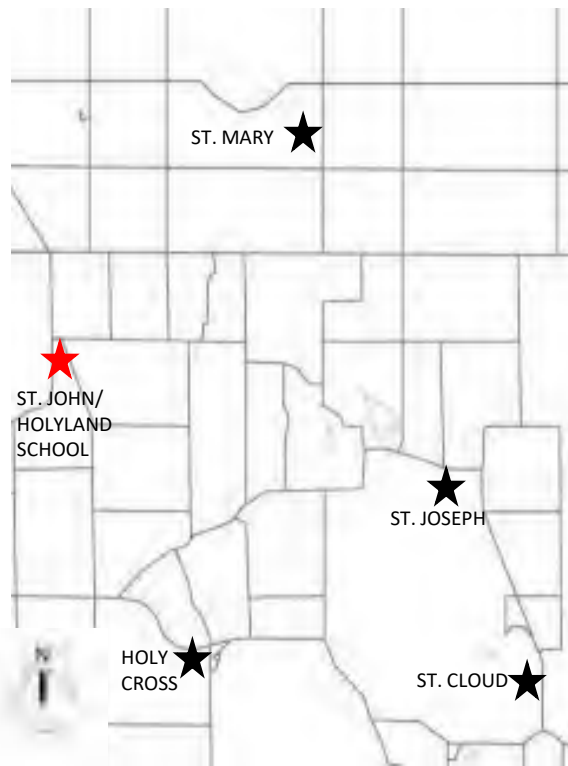
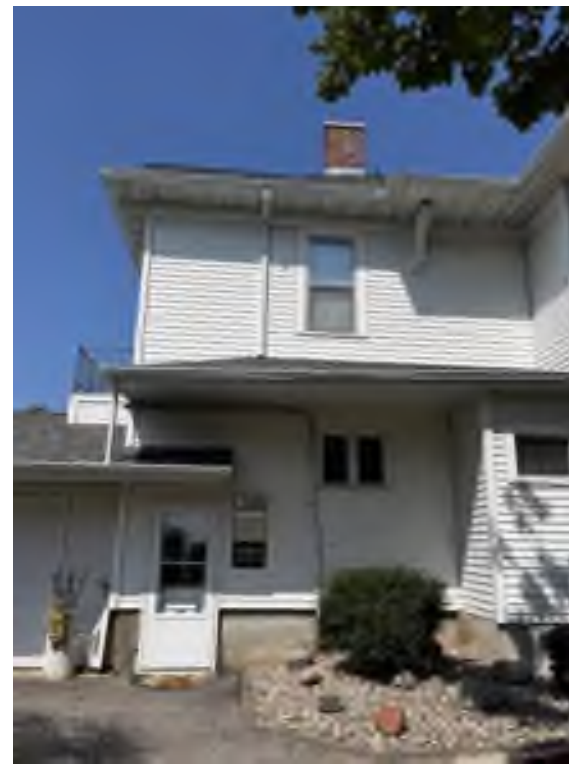
ROOF AGE:	25-30 years old, garage is 15 + years old
ROOF TYPE:	Asphalt Shingles
CONDITION:	Moderate
RECENT REPAIRS:	Sections along southwest corner replaced due to wind damage
RECOMMENDED REPAIRS:	Exposed metal valleys rusting, Masonry on chimney in need of repair
REMAINING LIFE:	2-4 Years

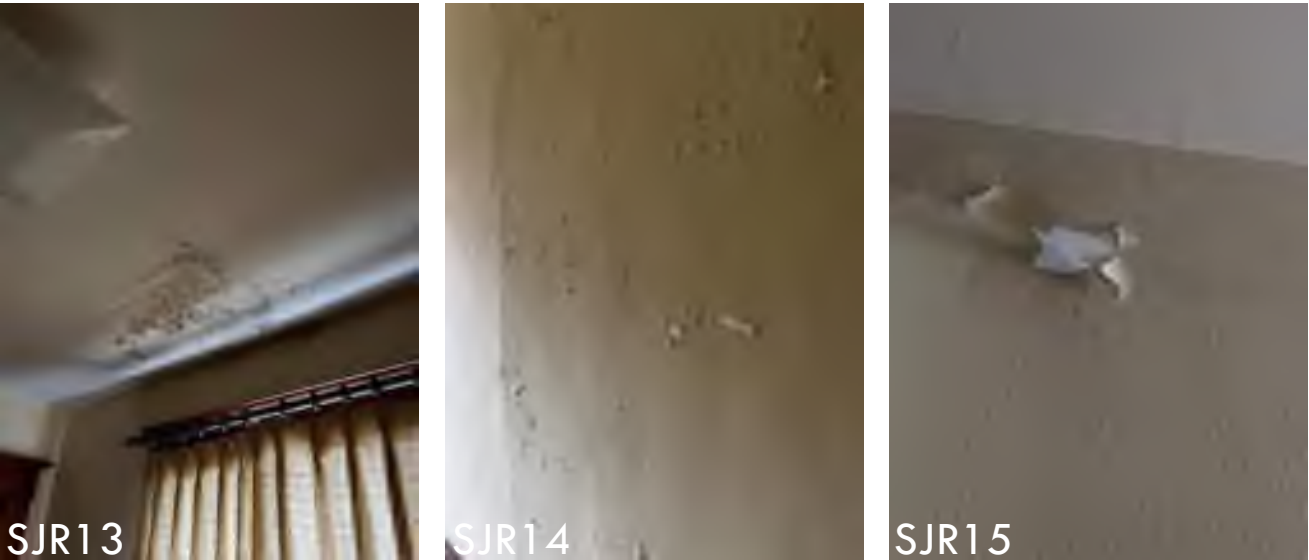
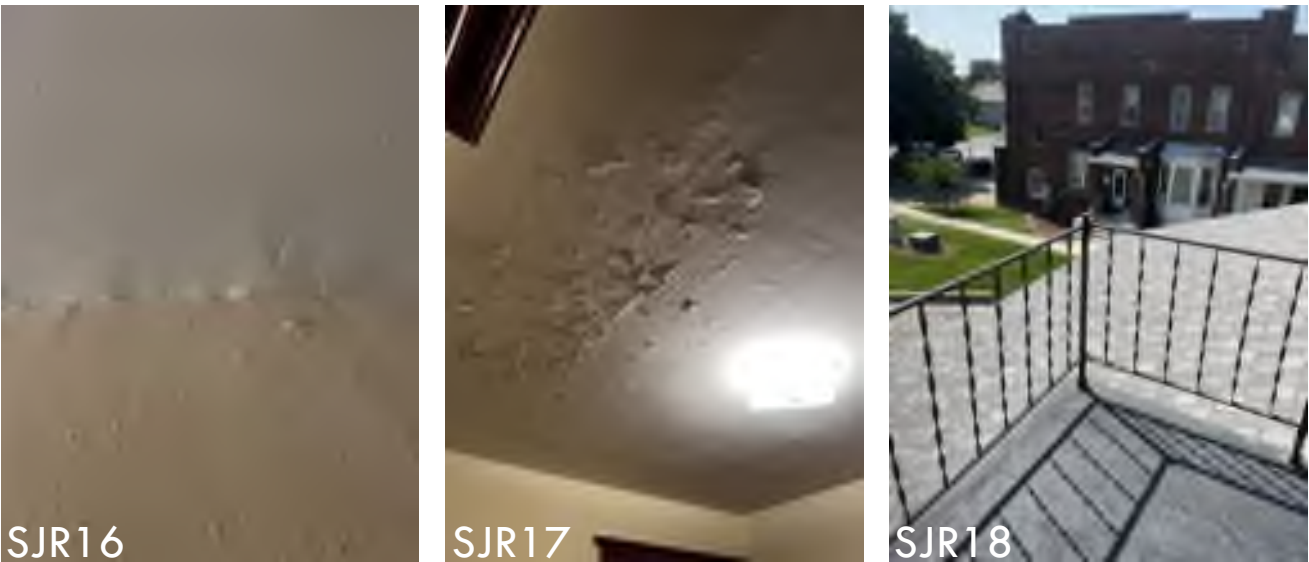
- SJR13 – Significant peeling & cracking at ceiling conditions.
- SJR14 – Significant peeling at plaster walls
- SJR15 – Significant peeling at plaster walls
- SJR16 – Significant bubbling at ceiling to wall transition.
- SJR17 – Significant peeling at ceiling conditions.
- SJR18 – Railing is not code compliant and is loose.

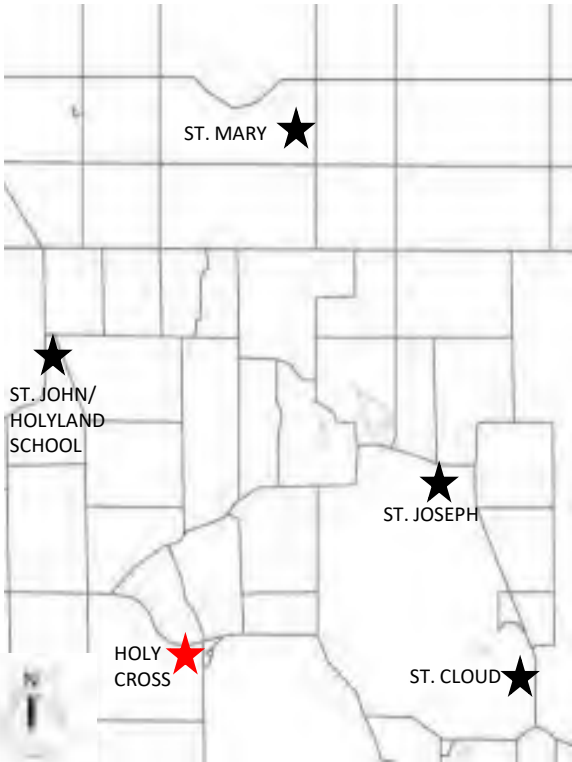
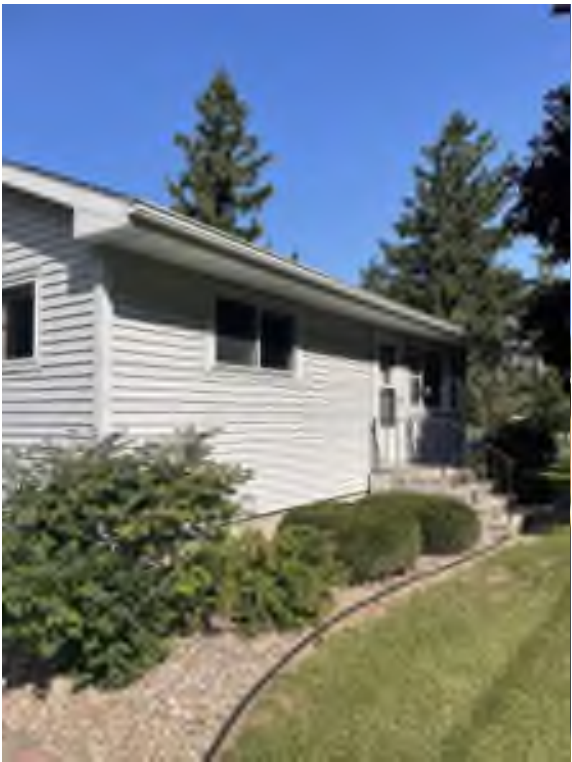
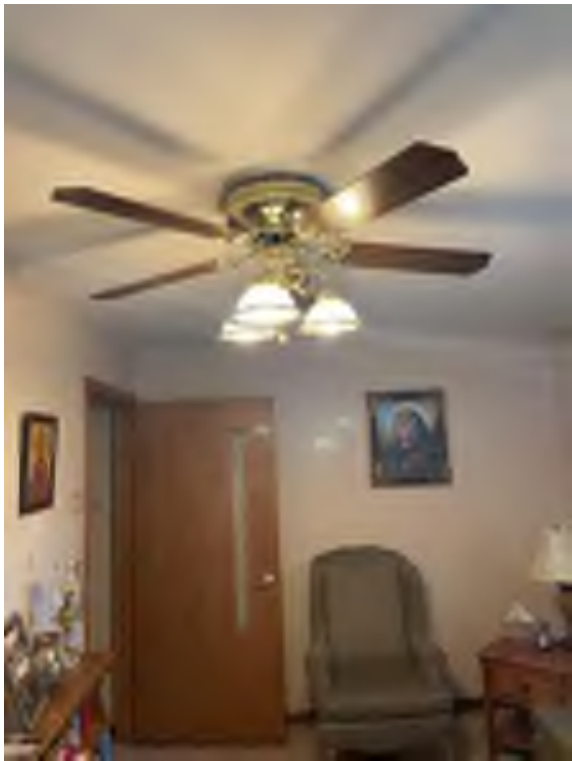
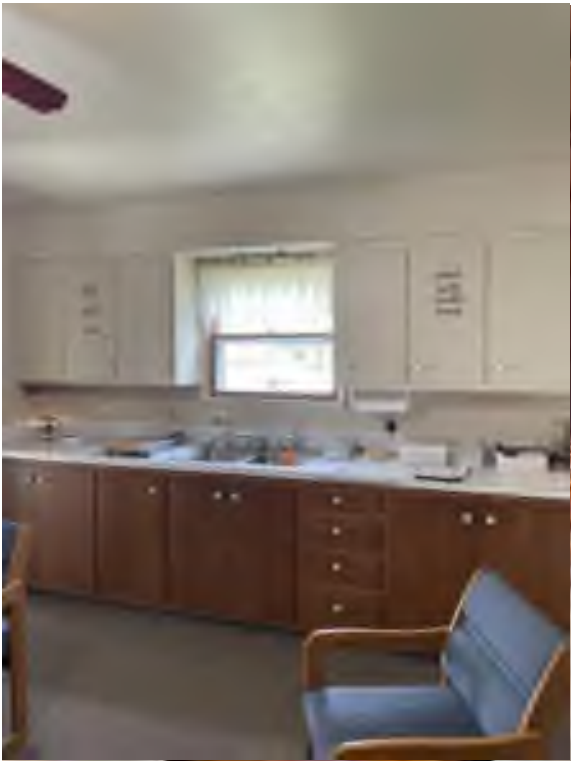
ROOF AGE:	18 years old
ROOF TYPE:	Asphalt Shingles
CONDITION:	Good
RECENT REPAIRS:	None Noted
RECOMMENDED REPAIRS:	No issues
REMAINING LIFE:	6-8 Years

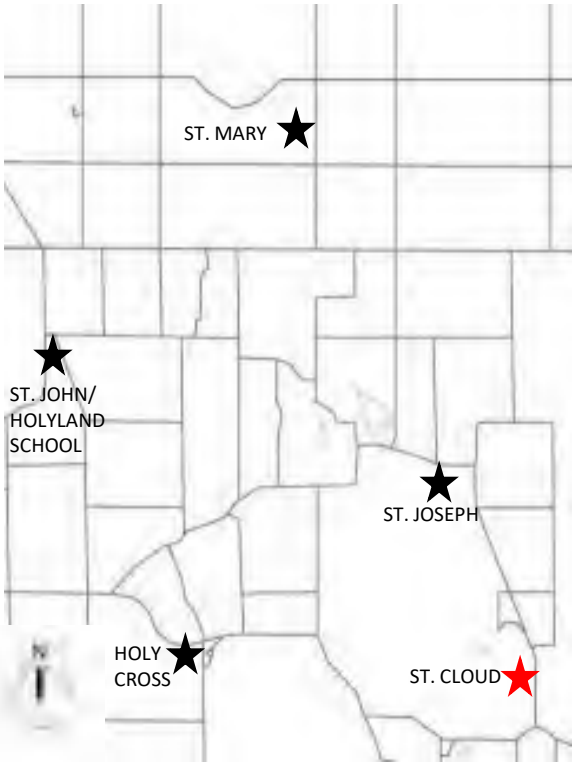
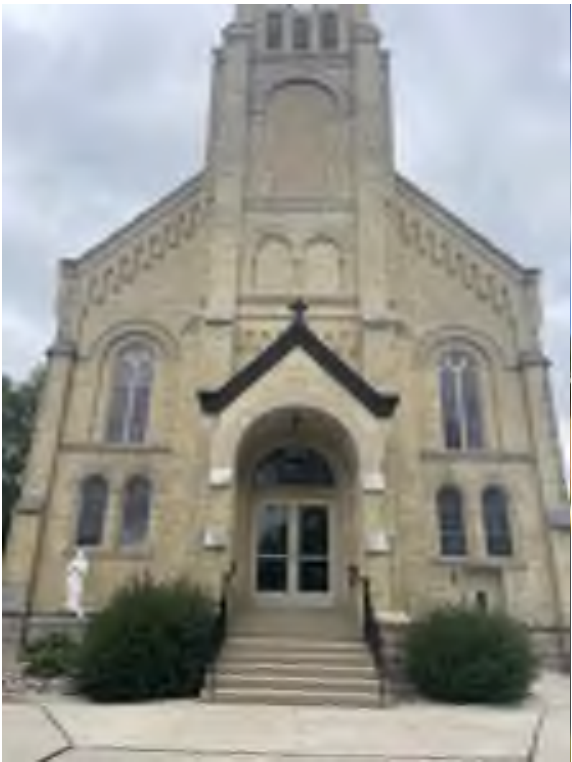
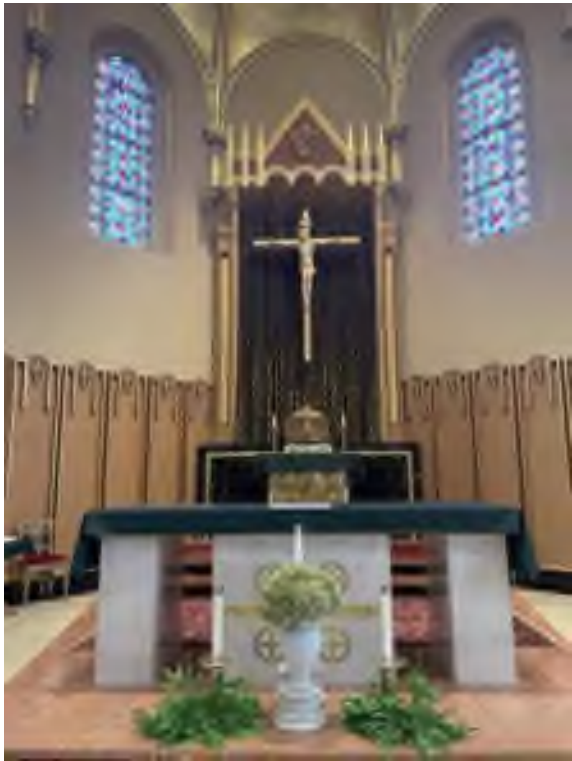
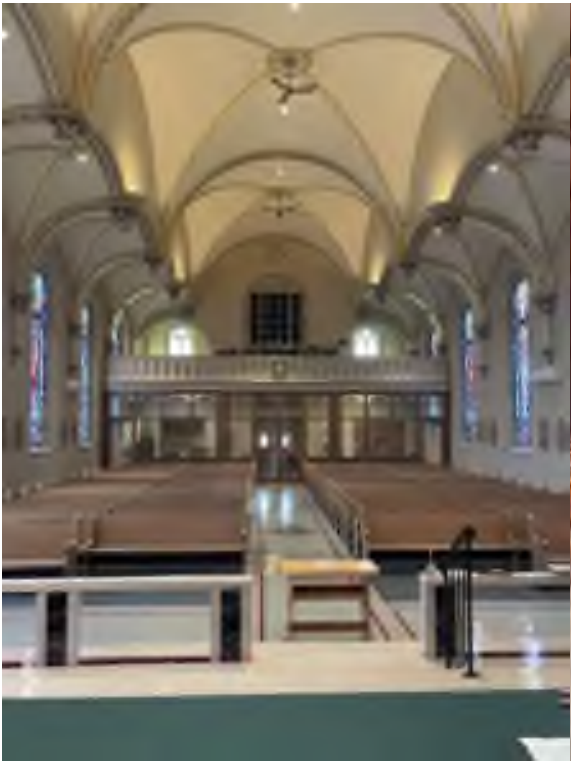
ROOF AGE:	21 years old
ROOF TYPE:	Asphalt Shingle
CONDITION:	Moderate
RECENT REPAIRS:	None Noted
RECOMMENDED REPAIRS:	Some granule loss and cracks on shingles on south elevation, deteriorated masonry at bell tower and west walls
REMAINING LIFE:	5-7 Years

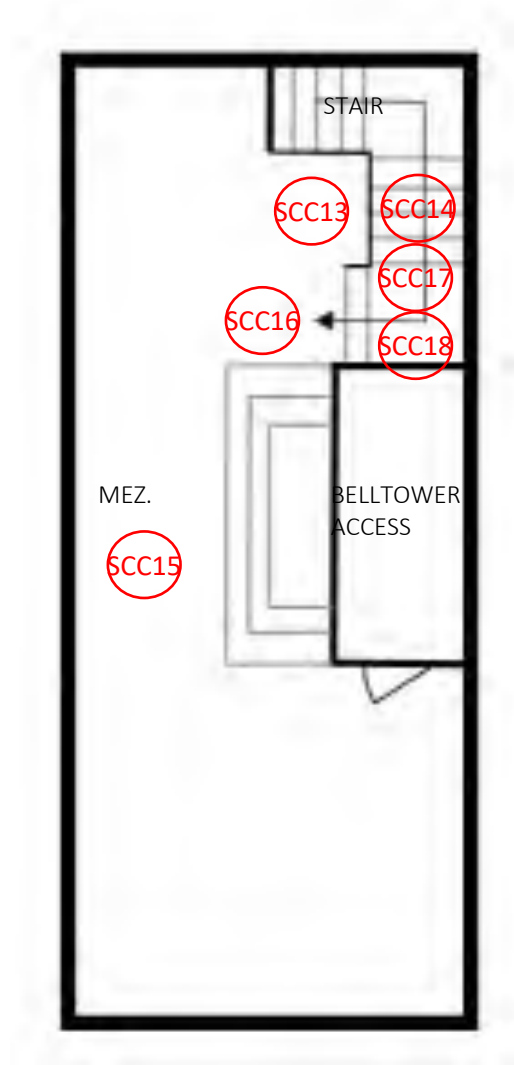
SCC13 & SCC14 – Railing only provided at one side of stair
SCC15 – Guardrail is not code compliant
SCC16 – Mezzanine Occupancy is limited to 29, current provided seats may be higher than allowed occupancy.
SCC17 & SCC18– Cracking at window sills

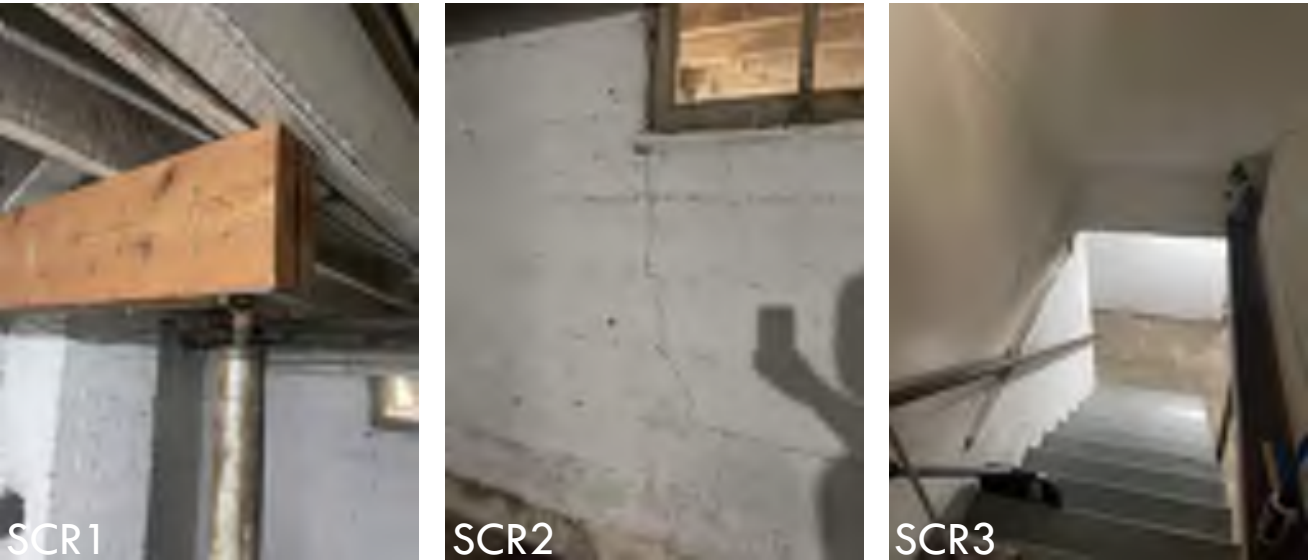
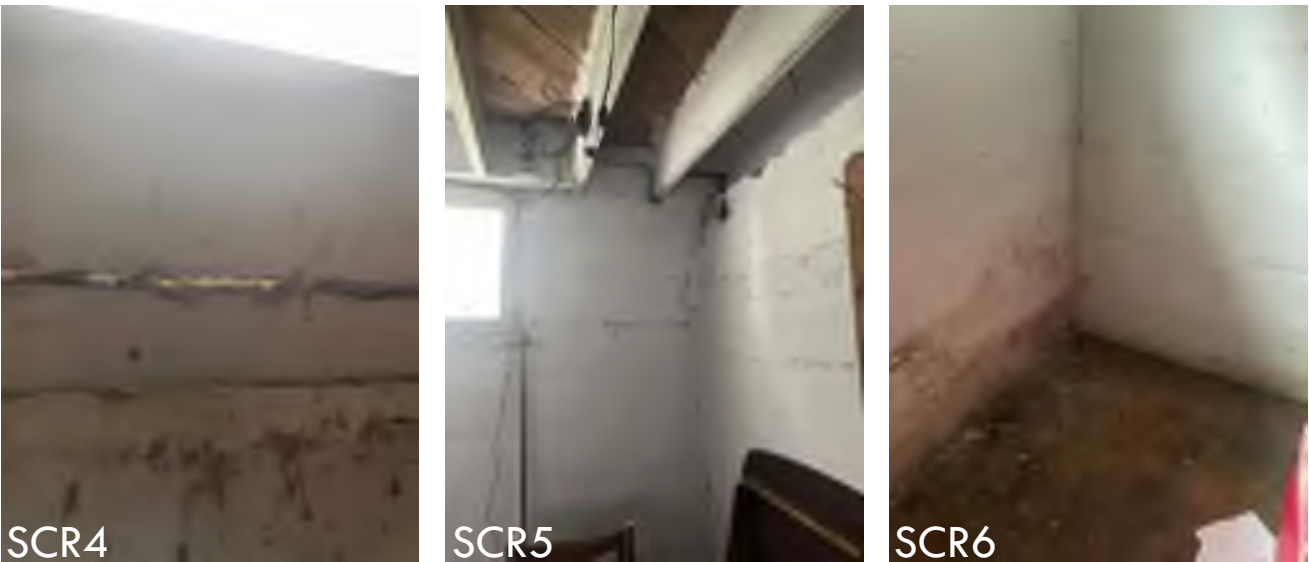
- SCR1 – Beams are not properly secured to existing pipe shoring.
- SCR2 – Cracking along exterior wall.
- SCR3 – No railing at exposed side of stair, cracking/plaster missing.
- SCR4 – Gaps in existing windows, may be past useful life.
- SCR5 – Cracking in corners at foundation wall
- SCR6 – Water damage at foundation, not wet at time of site visit.

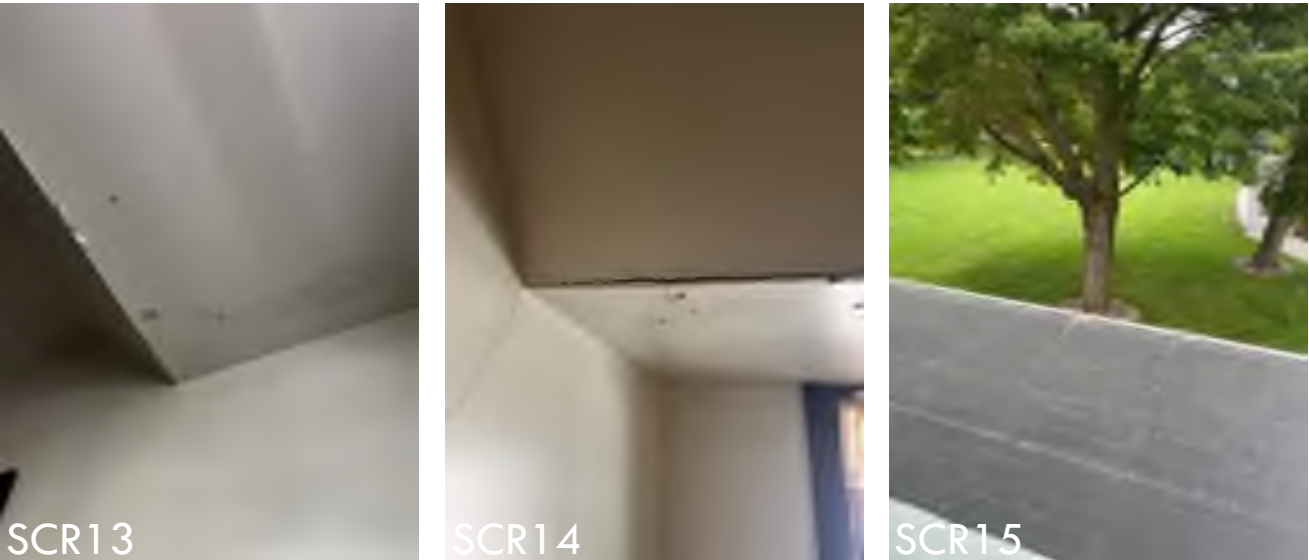
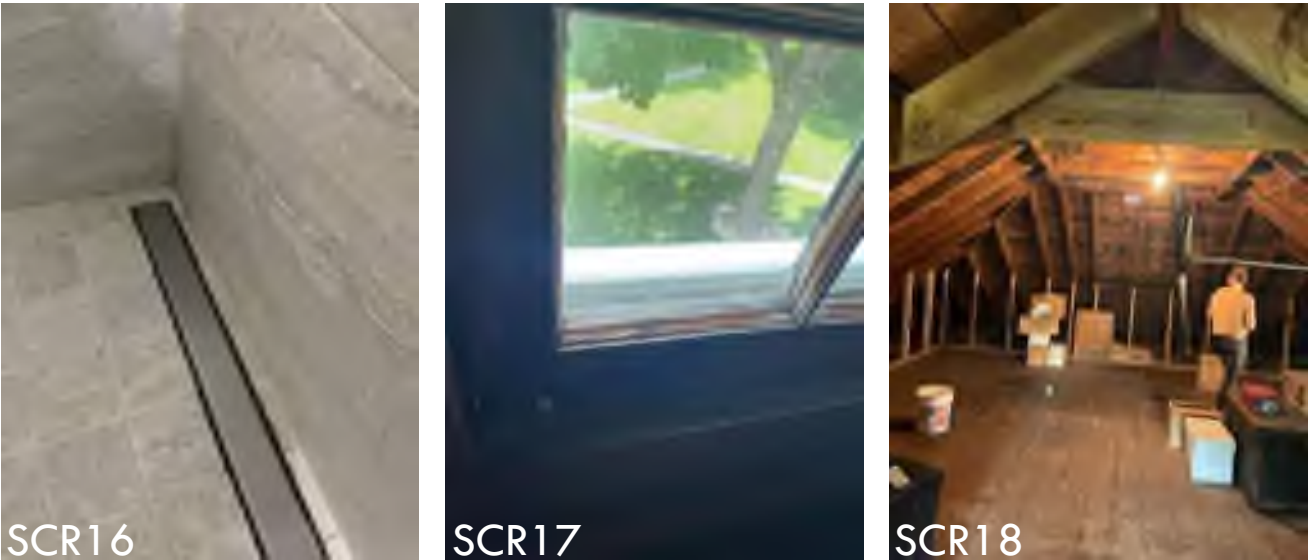
- SCR13 – Chipping paint at ceiling.
- SCR14 – Cracking at ceiling transition.
- SCR15 – No railing at balcony, door should be sealed.
- SCR16 – Mildew build up at corners of tile.
- SCR17 – Attic – Rotting at window muttons.
- SCR18 – Attic – Water damage on wood decking, may have been from previous roof.

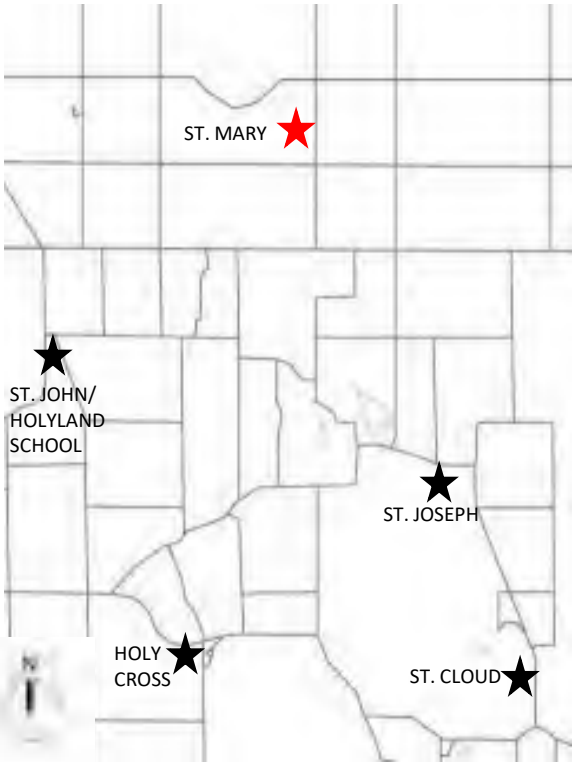
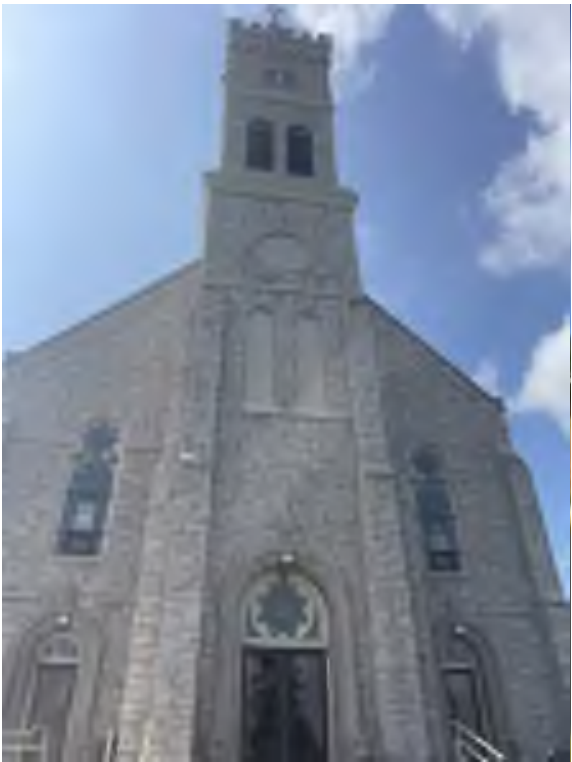
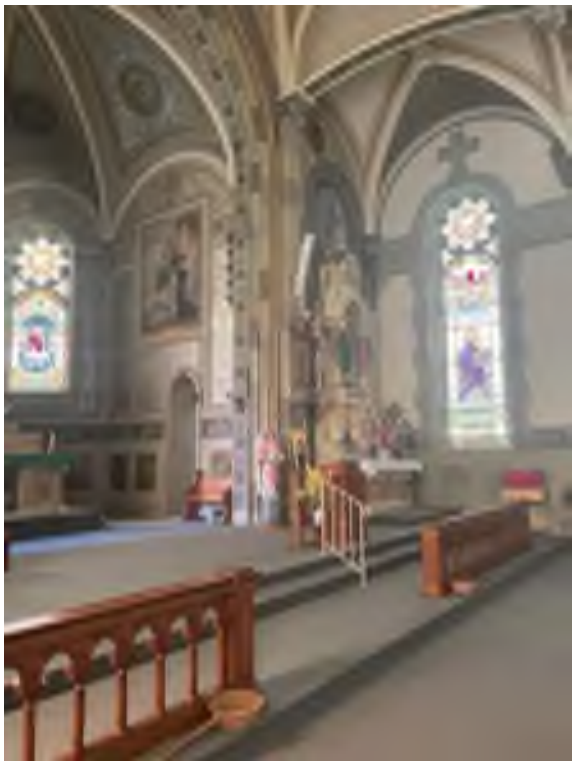
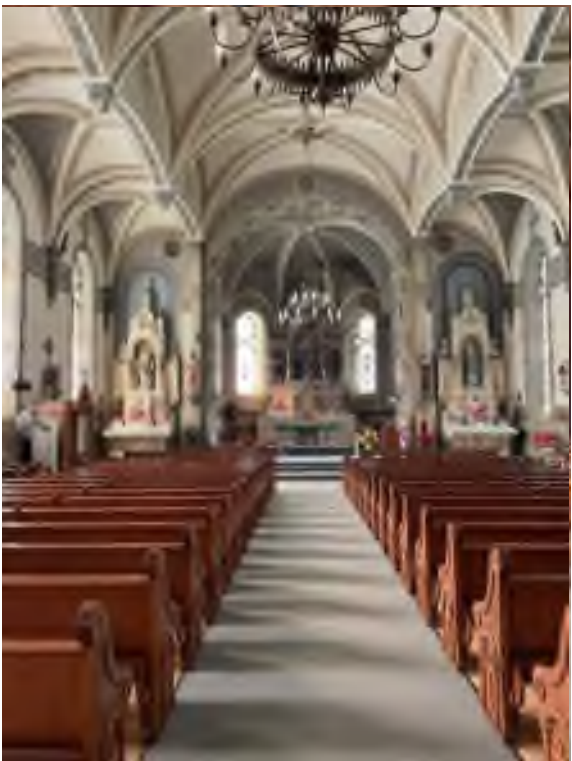
ROOF AGE: 5 years old
ROOF TYPE: Asphalt Shingle
CONDITION: Good
RECENT REPAIRS: None Noted
RECOMMENDED REPAIRS: Downspout missing on southwest corner of sanctuary, loose metal flashing at north side of bell tower, loose copper seams along outer edge of gutter.
REMAINING LIFE: 20+ Years

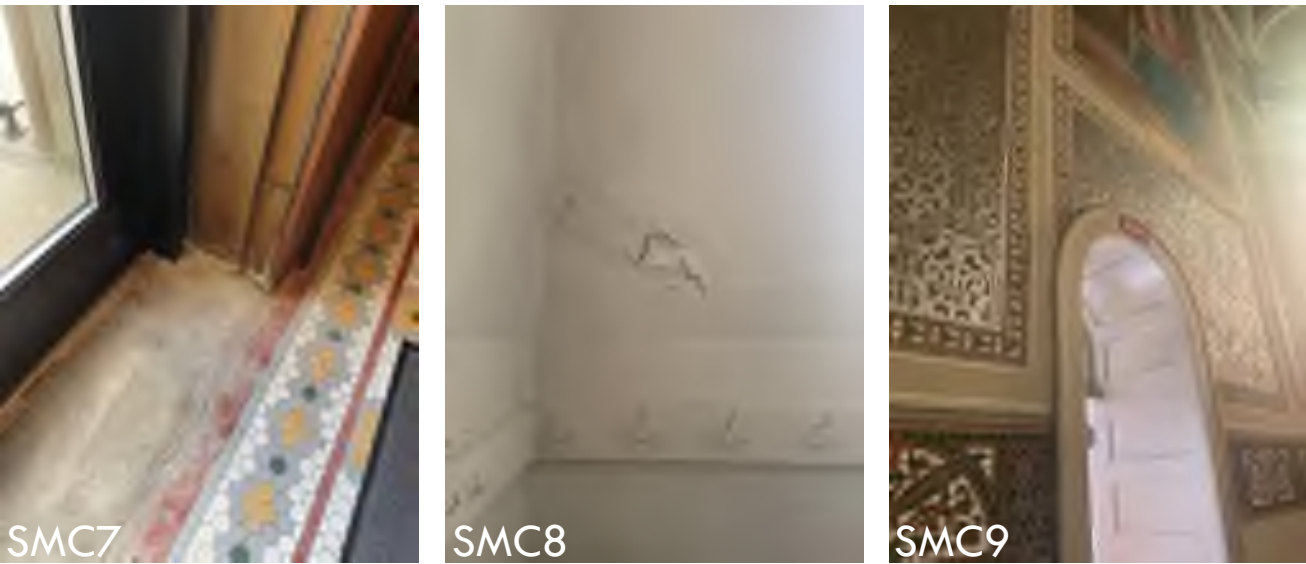
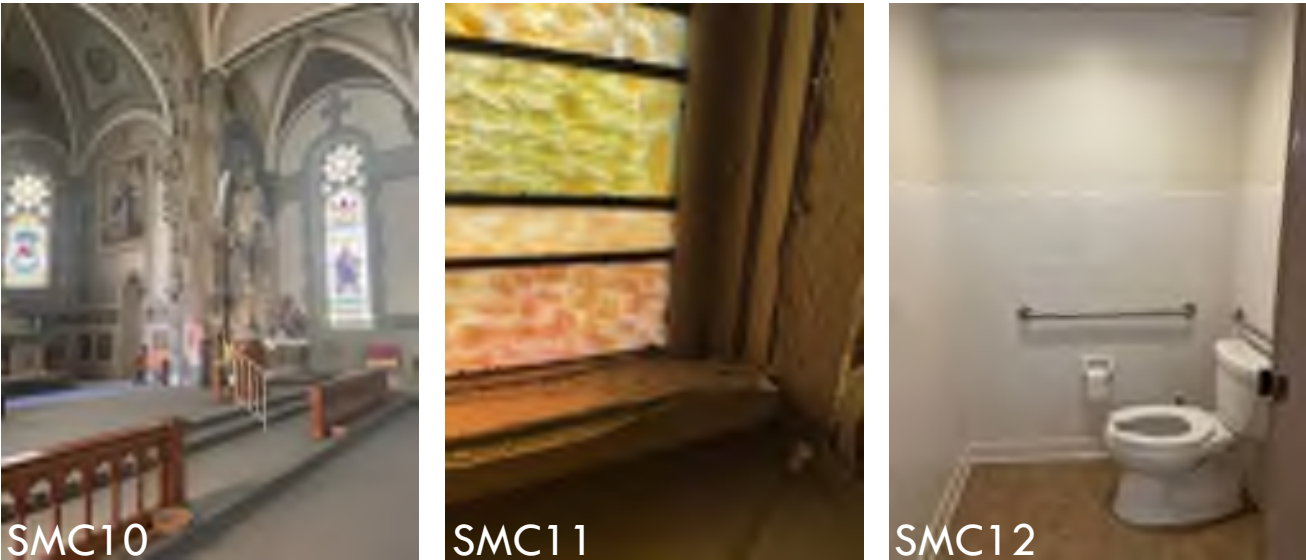
- SMC7 – Weathering/Rotting at door jambs
- SMC8 – Cracking at plaster walls.
- SMC9 – Exit sign is provided above egress door, sign is not illuminated
- SMC10 – ADA ramp is not provided at sanctuary, not a code issue but something to note for elderly congregation members.
- SMC11 – Mildew forming at stained glassing, wood chipping at jambs
- SMC12 – Restroom is not ADA compliant.

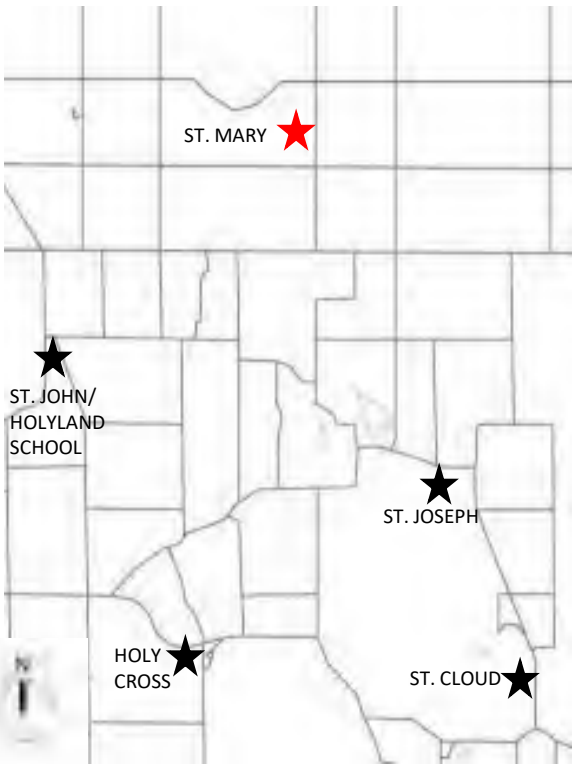
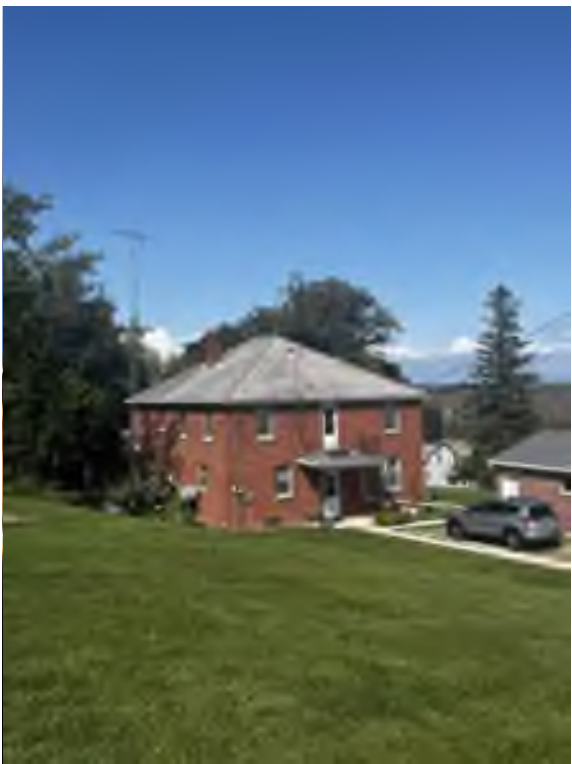
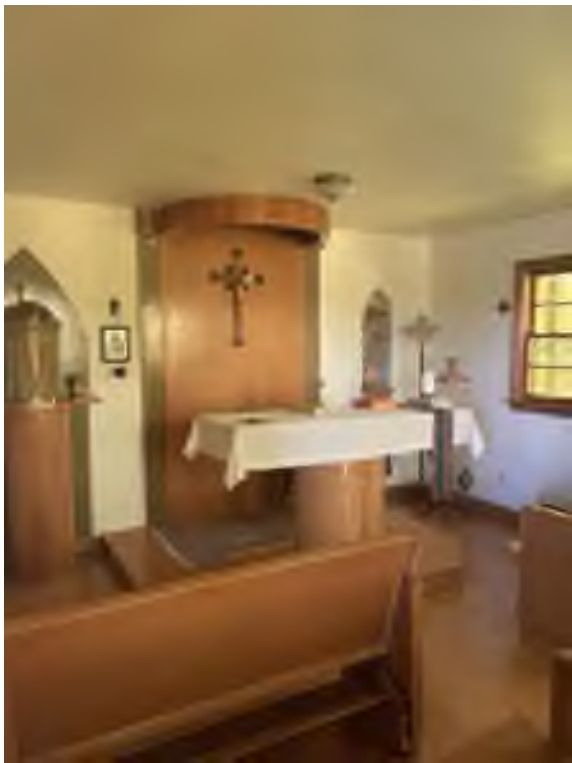
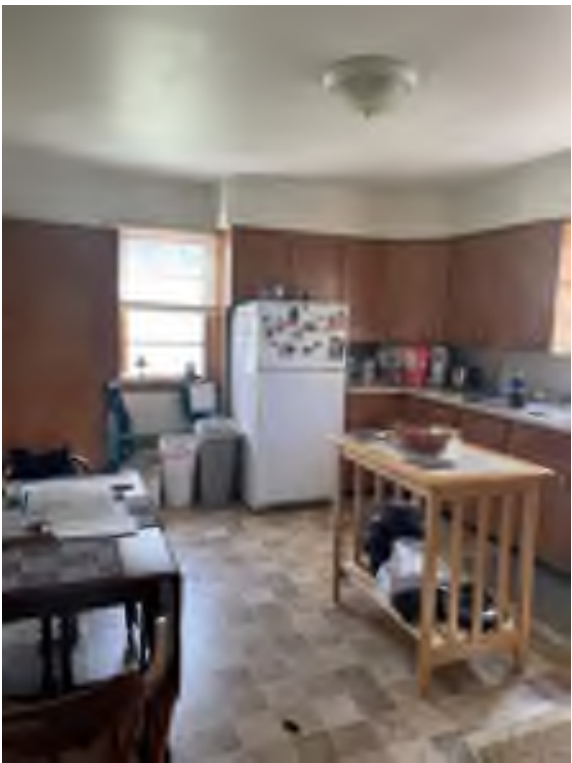
ROOF AGE:	Unknown (Original)
ROOF TYPE:	Slate Tile (Assumed Asbestos)
CONDITION:	Poor
RECENT REPAIRS:	None Noted
RECOMMENDED REPAIRS:	Loose/buckled tile at base of chimney, exposed wood under hip capping (underlayment under capping assumed to be deteriorated), deteriorated mortar at chimney.
REMAINING LIFE:	1-3 Years

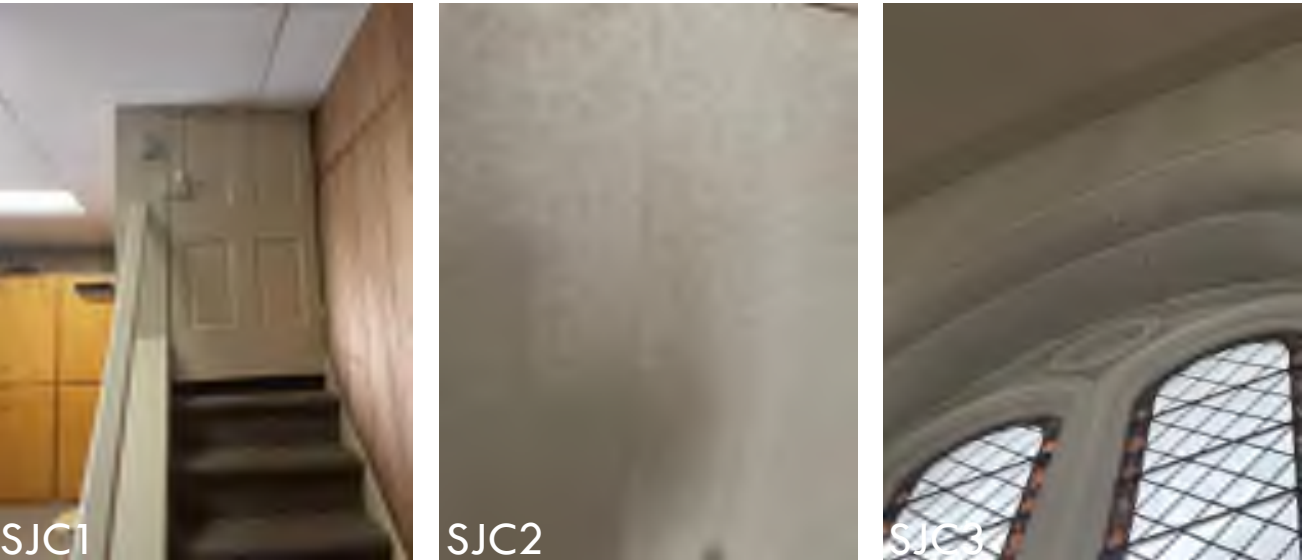
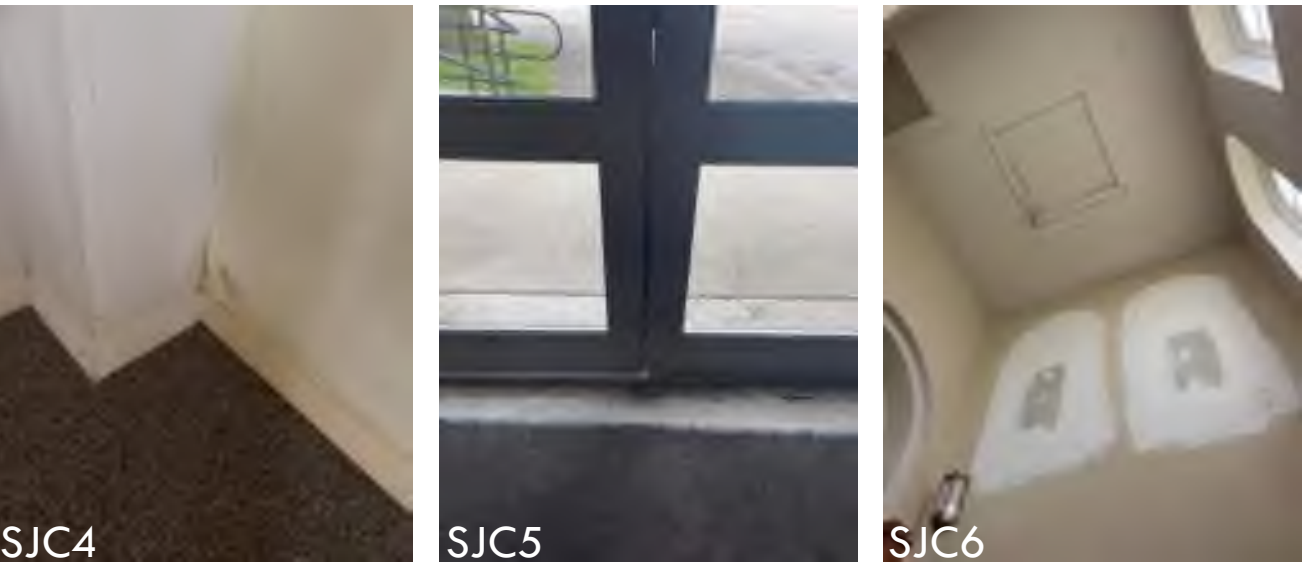
- SJC1 – Storage door does not have proper clearances or landing.
- SJC2 – Mildew at some FRP conditions.
- SJC3 – Cracking at window head.
- SJC4 – Mildew & peeling FRP.
- SJC5 – Door has gaps, seals need replacement.
- SJC6 – Windows were removed at patched, paint needed at locations.

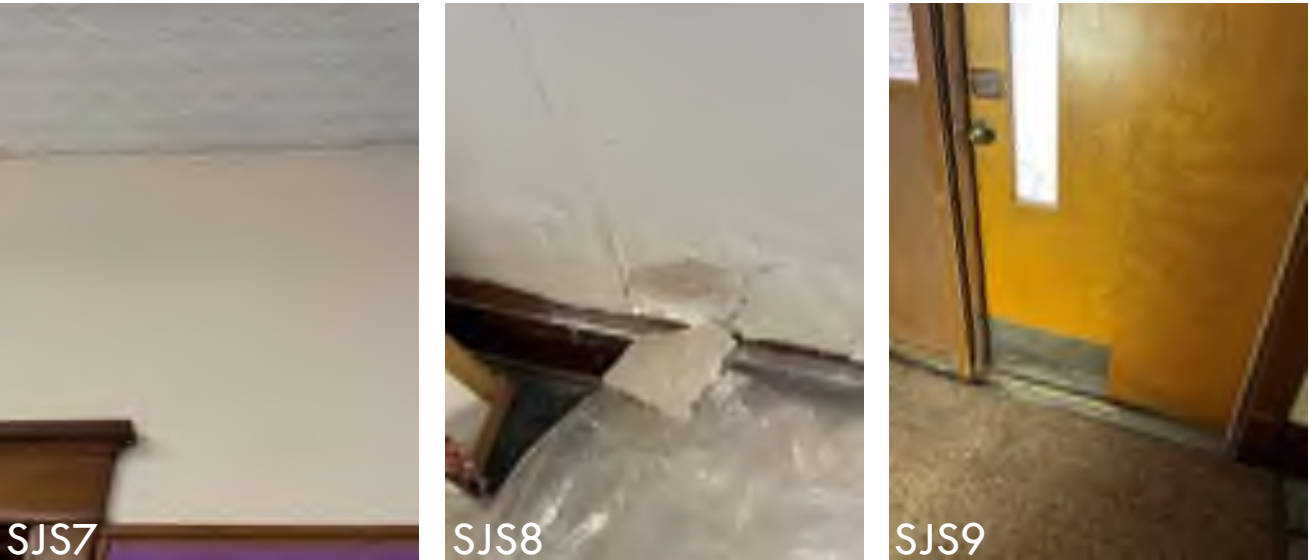
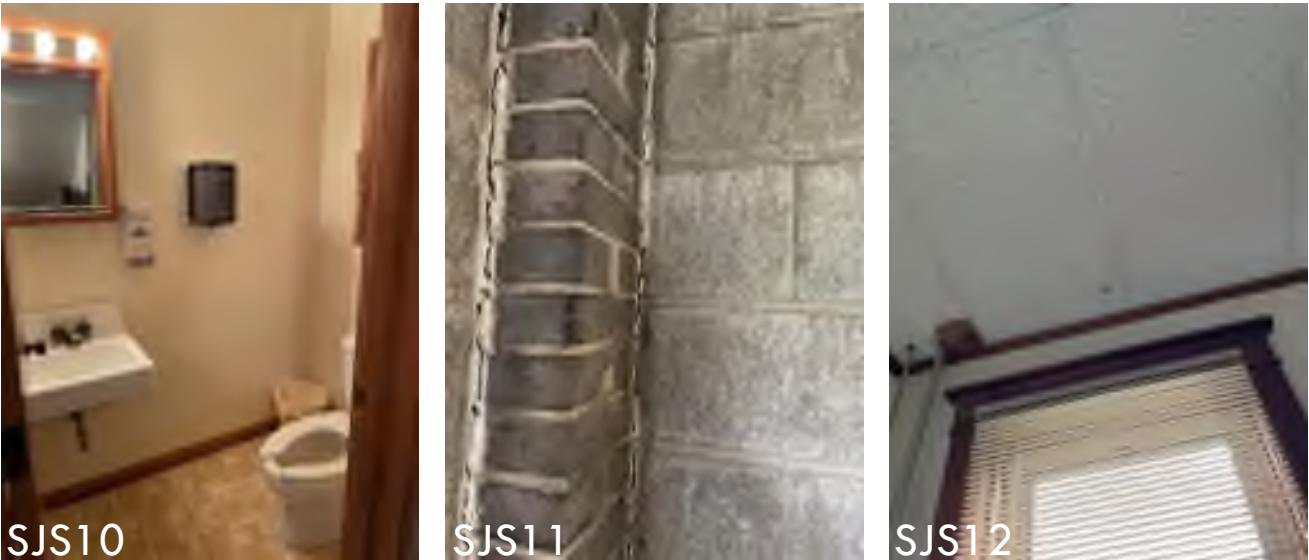
- SJS7 – Cracking at existing plaster.
- SJS8 – Plaster peeling away from walls.
- SJS9 – Building does not have a code compliant entry.
- SJS10 – Restrooms are not ADA compliant
- SJS11 – Sealant in vestibule is failing in locations
- SJS12 – Significant water damage in ceiling, remove ceiling tile to investigate. Some exterior windows need replacement, some are new.
