OUR LADY OF THE HOLYLAND PARISH

EXISTING FACILITIES CONDITIONS REPORT

DECEMBER 1, 2023

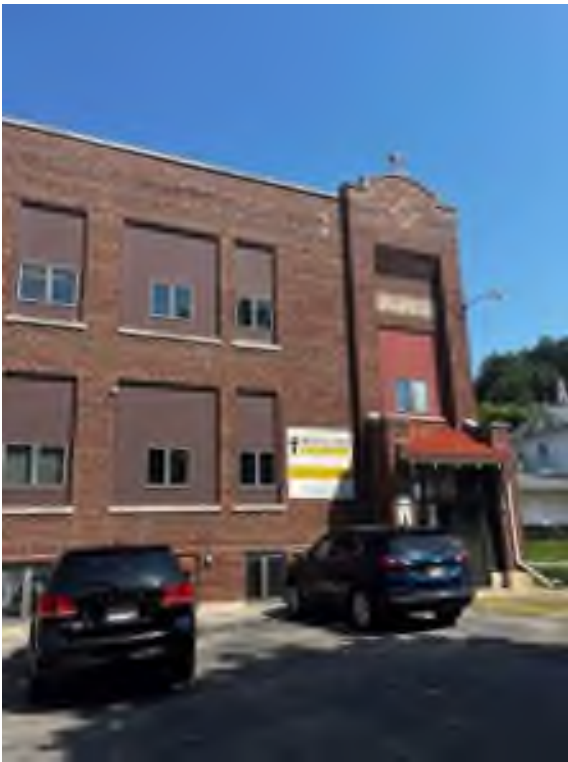
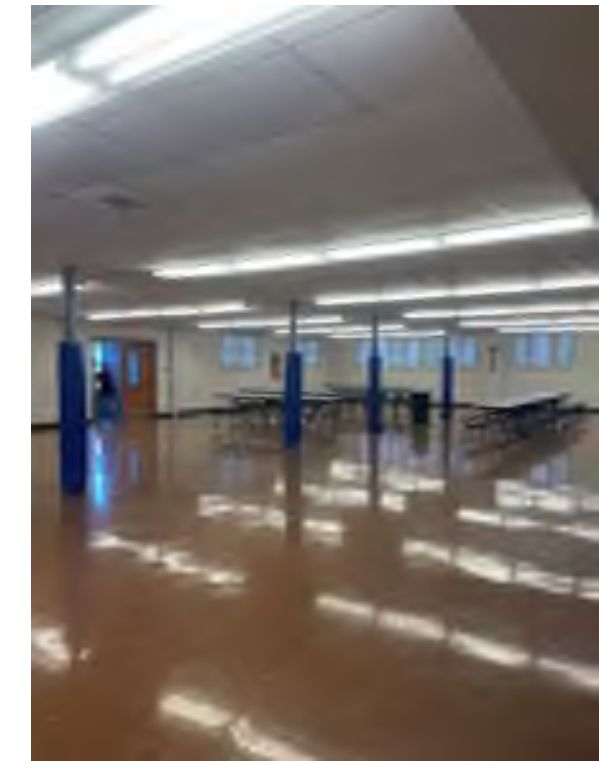
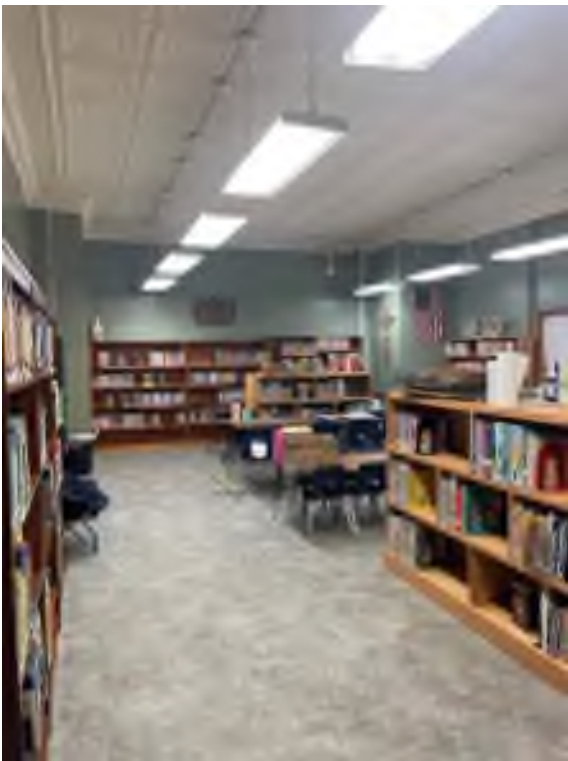
SCHOOL ADDITON/ LOW ROOF

Stressed membrane flashing at curb penetrations will need repair, displaced stone ballast from previous leak investigation
- REMAINING LIFE:

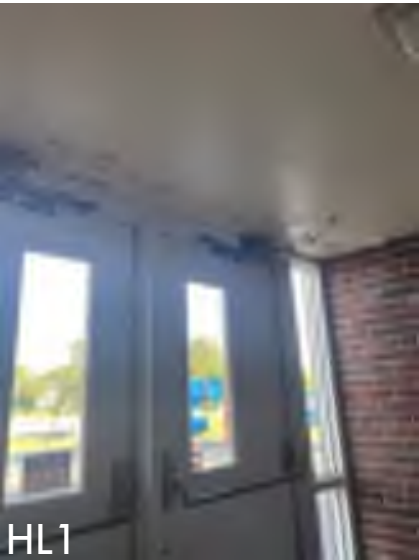
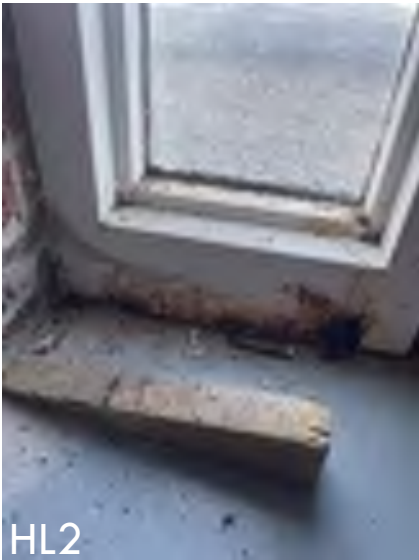
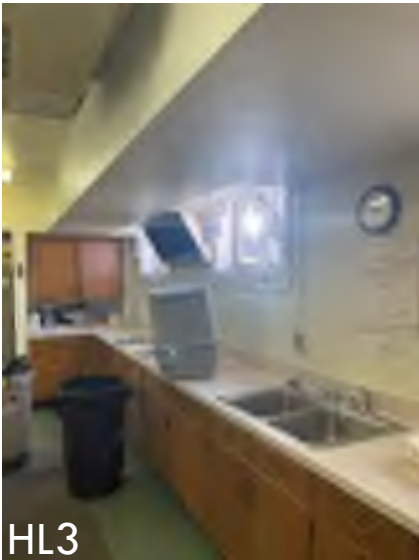
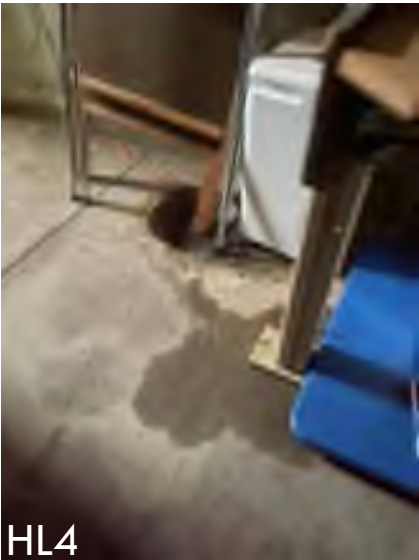
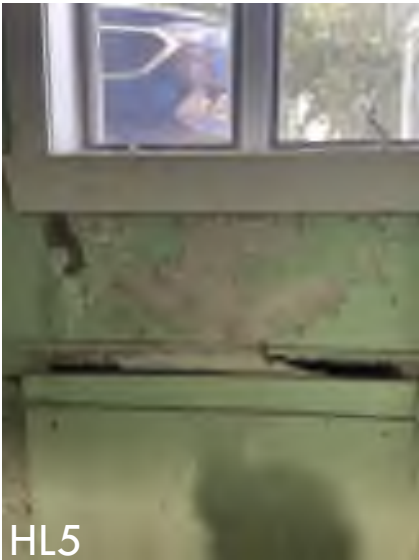
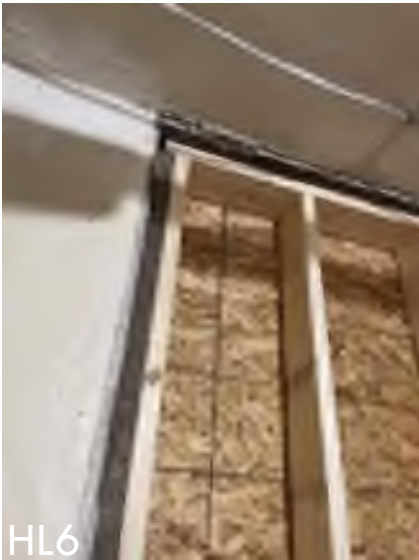
- HL1 – Moisture seems to be an issue in the vestibule, concrete was weathering, ceiling was peeling, brick had signs of efflorescence.
- HL2 – Rust/Weathering is present at exterior door jambs.
- HL3 – Kitchen exhaust is dated, counters are not ADA compliant.
- HL4 – Water was present around the dehumidifier/floor drain.
- HL5 – Cracking/Peeling Paint/Gaps at exterior wall in the water room.
- HL6 –At infilled windows ensure infill has insulation and is properly sealed.

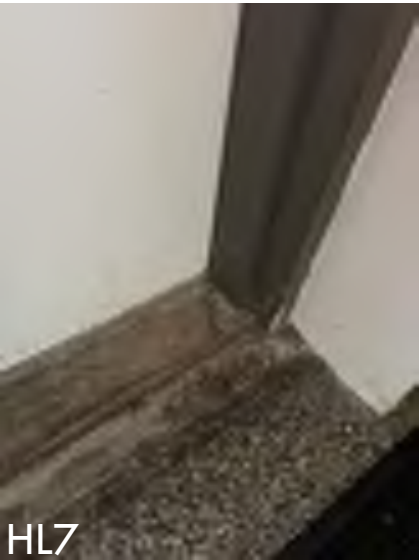
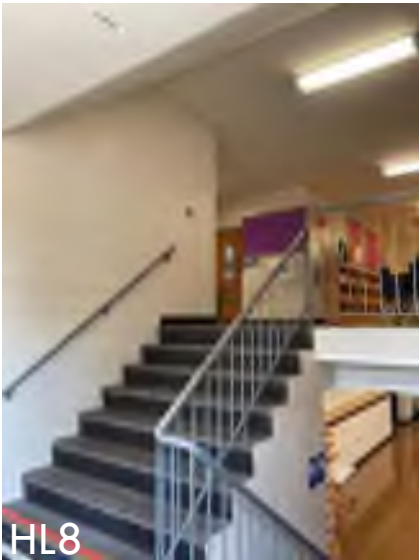
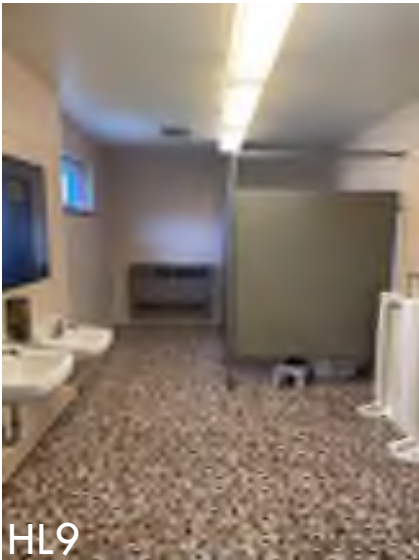
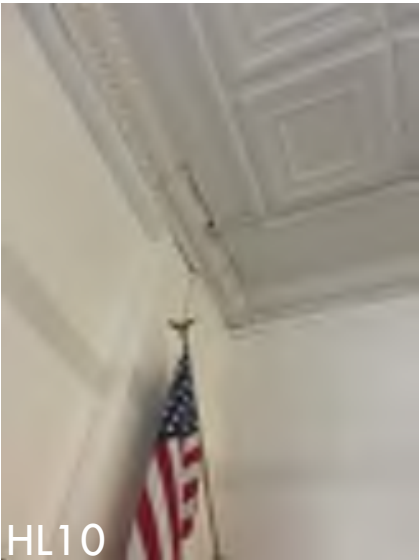
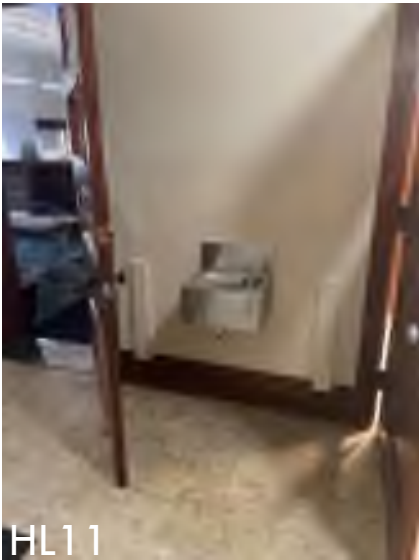
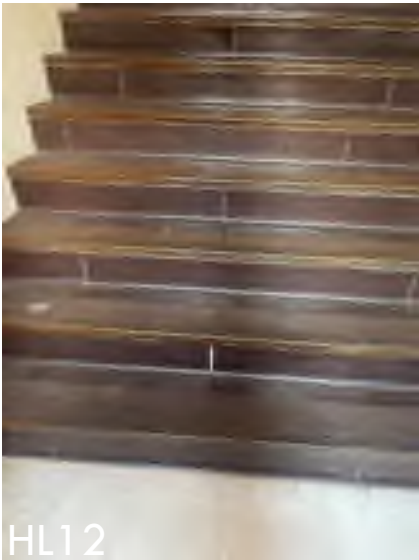
- HL7 – weathering/rot at wood door threshold (various locations).
- HL8 – No ADA access is provided to any floor, guardrail is not compliant
- HL9 – No ADA stall is provided in either restroom.
- HL10 – Cracking in tin ceiling (various locations).
- HL11 – Drinking fountain is in-between 2-180 degree doors, not appropriate ADA clearances.
- HL12 – Vinyl risers are peeling on the stairs creating a tripping hazard.

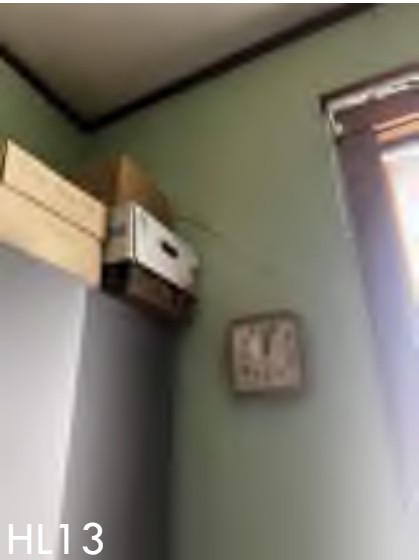
- HL13 – Significant cracking in plaster wall (various locations).
- HL14 – Corrosion of tin ceiling (various locations).
- HL15 – Cracking/missing sections of floor tile, may cause trip hazard.
- HL16 – Cracking in plaster ceilings (various locations)
- HL17 – Water damager above door to faculty lounge
- HL18 – Small kitchenette is provided, casework is not ADA accessible.

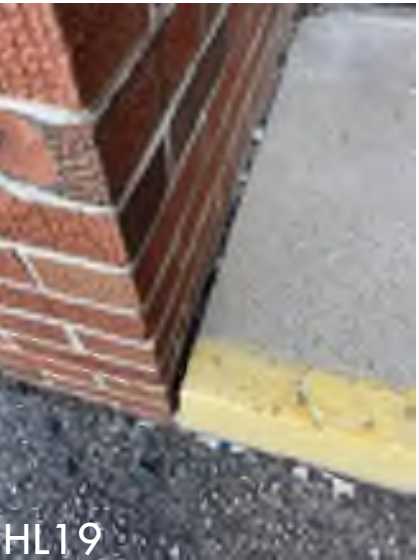
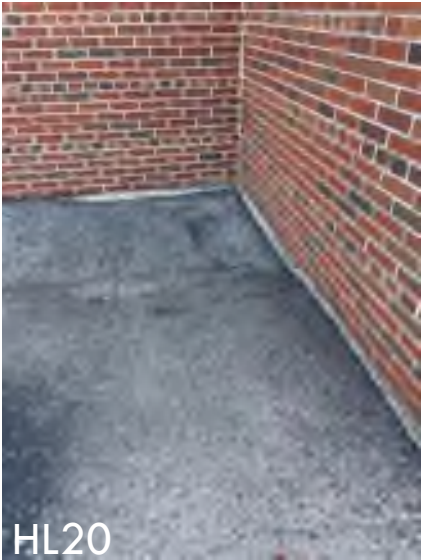
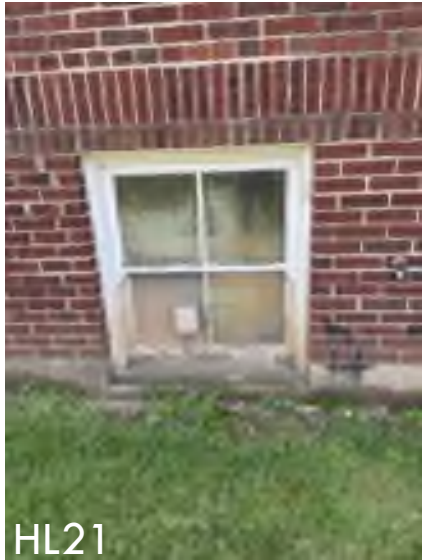
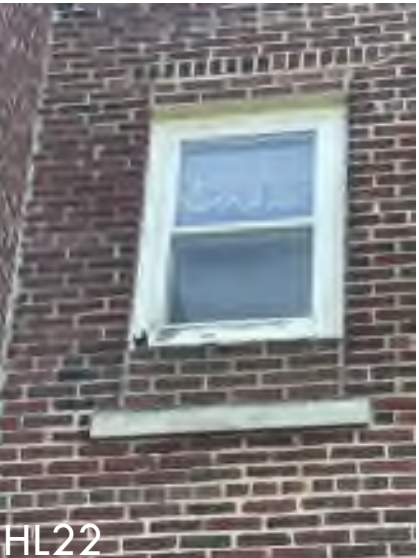
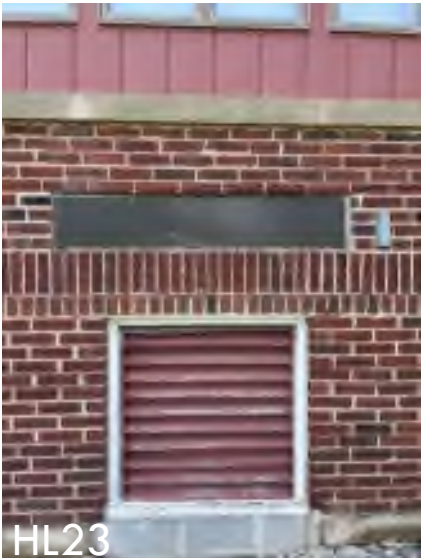
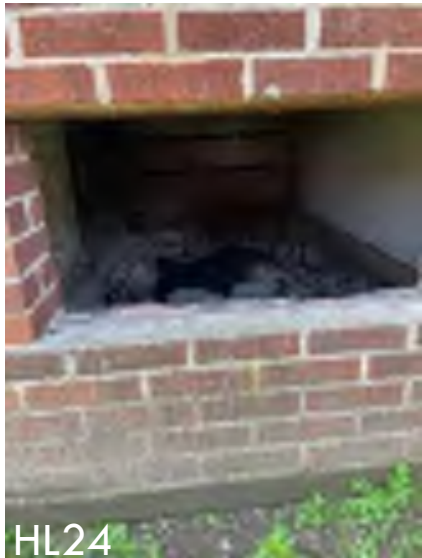
- HL19 – Expansion joint from concrete to brick needs to be replaced.
- HL20 – Asphalt is flat at building and does not maintain positive pitch.
- HL21 – Original single pane windows at grade are significantly weathered.
- HL22– Wood window hole has large hole.
- HL23 – Infilled CMU has gaps to existing building.
- HL24 – Large hole exists underneath patio, may want to close this off.

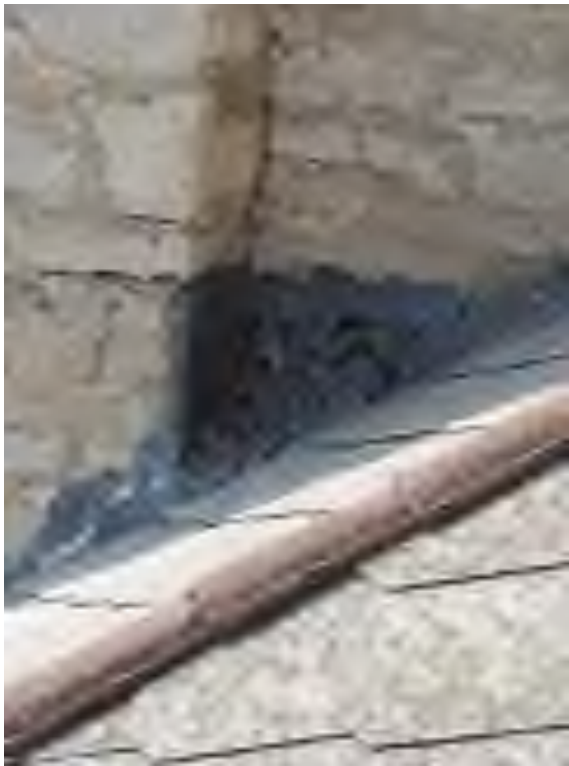
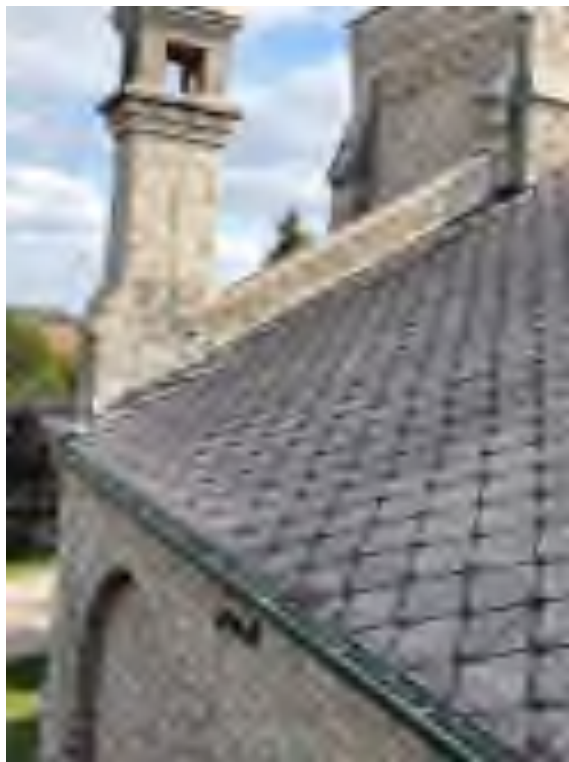
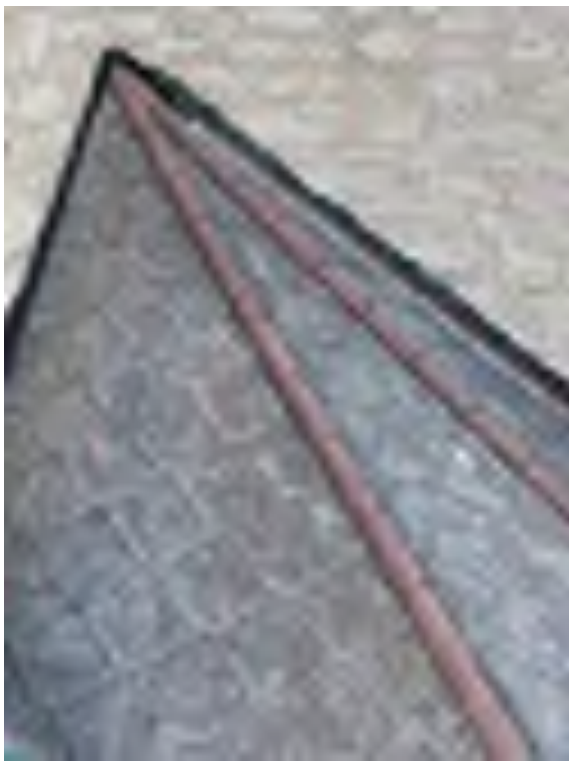
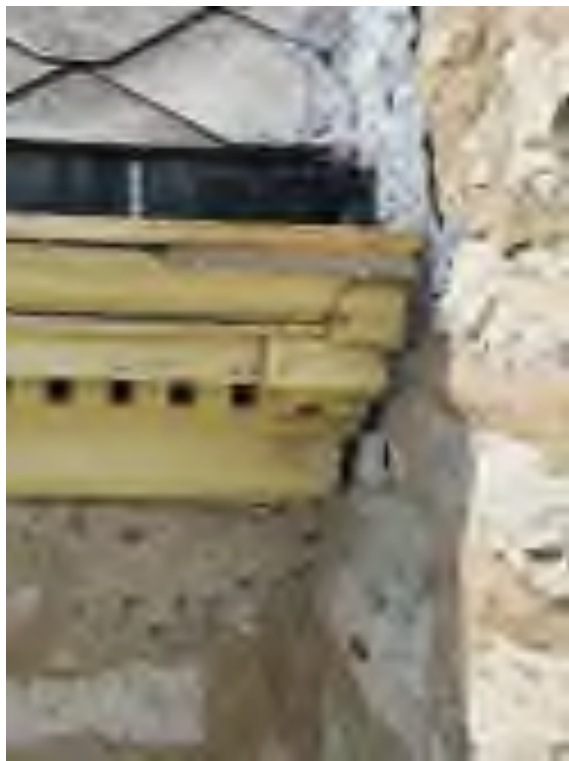
ROOF AGE:	Unknown (Original)
ROOF TYPE:	Slate Tile (Assumed Asbestos)
CONDITION:	Moderate
RECENT REPAIRS:	Wall flashing above vestibule
RECOMMENDED REPAIRS:	Additional flashing repairs needed in same area as listed under recent repairs
REMAINING LIFE:	5-7 Years

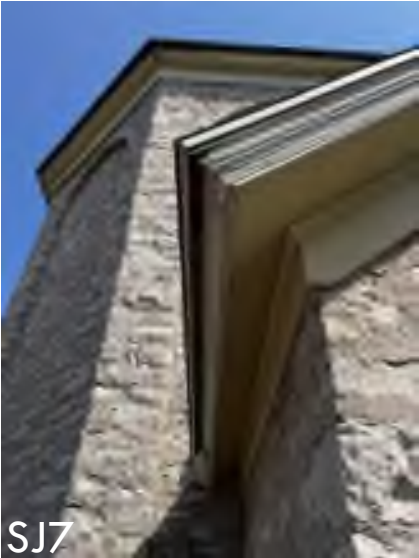
- SJ7 – Paint is peeling at fascia, trim is missing and roof nails are showing.
- SJ8 & SJ9 – Significant weathering at door jambs and sills.
- SJ10 – Large gaps in masonry, tuckpointing is needed.
- SJ11 – Large gaps in masonry, tuckpointing is needed.
- SJ12 – Exterior wood door and jambs are showing significant weathering.

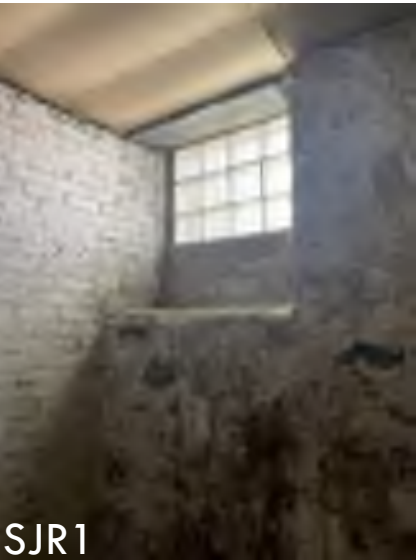
SJR1 – Foundation walls have significant staining and peeling paint.

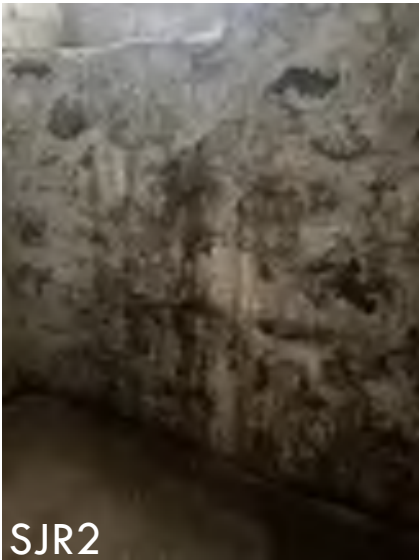
SJR2 – Foundation walls have significant staining and peeling paint.

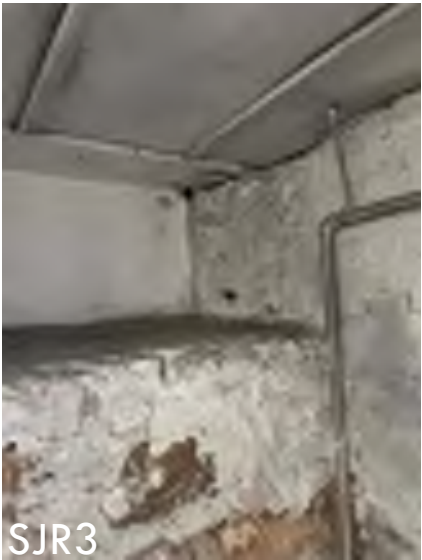
SJR3 – Foundation transitions have misc. holes that are daylight.

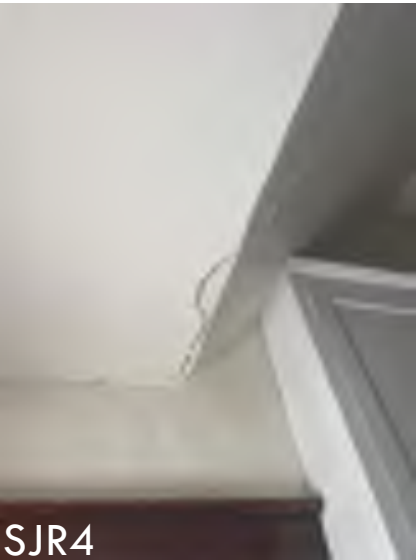
SJR4 – Existing plaster ceiling and stair has misc. cracking.

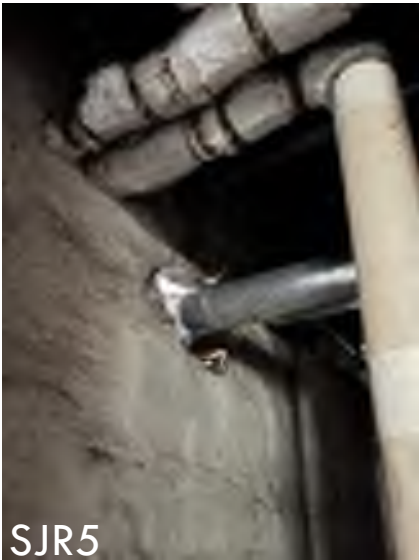
SJR5 – Vent to exterior is daylight, suggest insulating/patching.

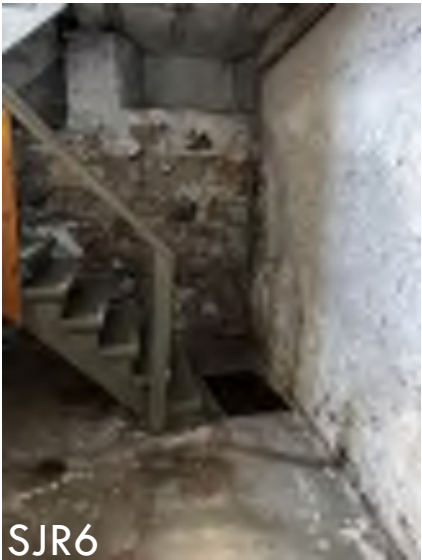
SJR6 – Much of the paint has chipped to the floor, indicating moisture issue.

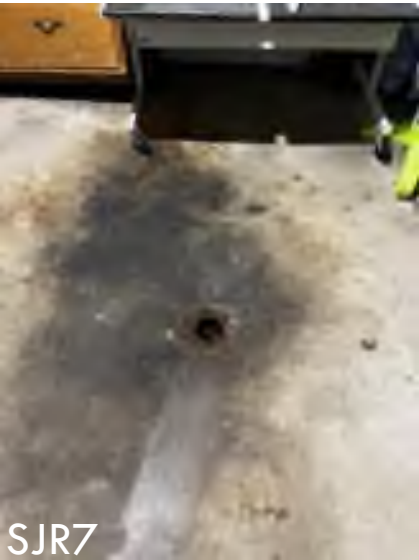
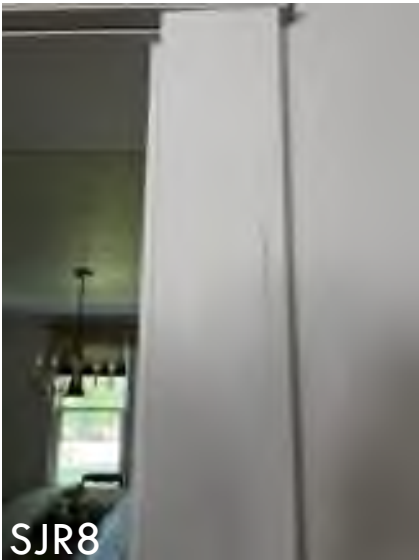
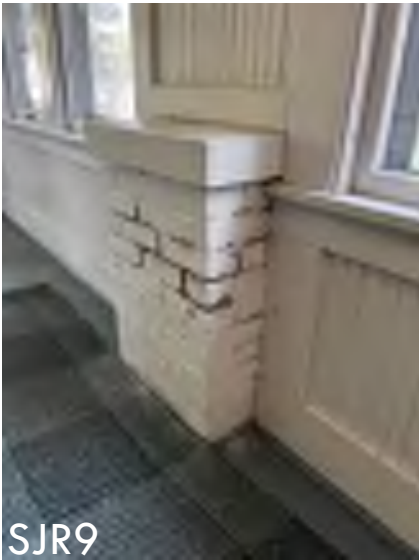
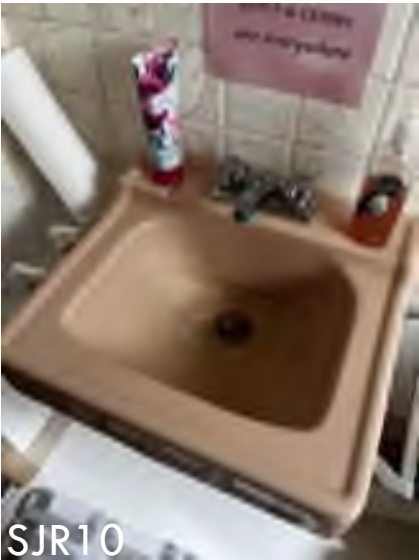
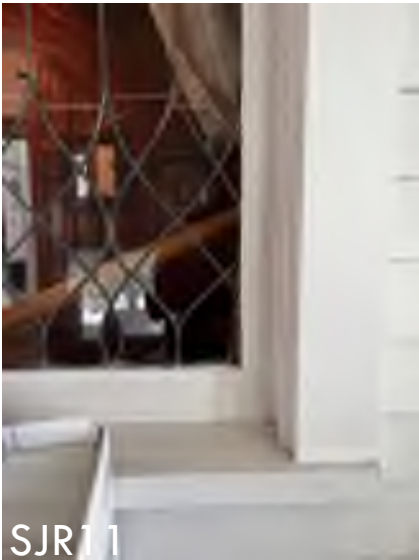
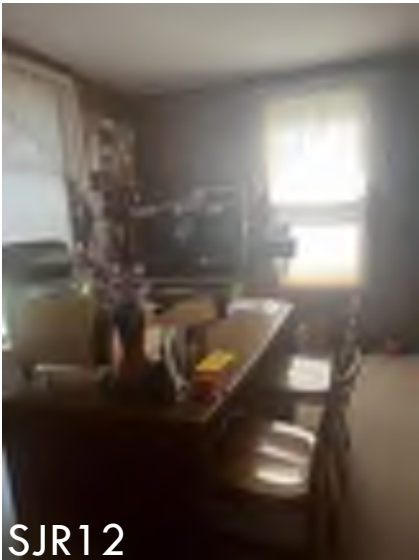
- SJR7 – Drain in garage is open, suggest adding a cover.
- SJR8 – Paint on wood is starting to peel.
- SJR9 – Brick in porch requires some tuckpointing.
- SJR10 – Bathroom is not ADA, sink has significant staining.
- SJR11 – Paint on wood in porch is significantly peeling in various locations.
- SJR12 – House is used for office purposes, access to the house is not ADA accessible.

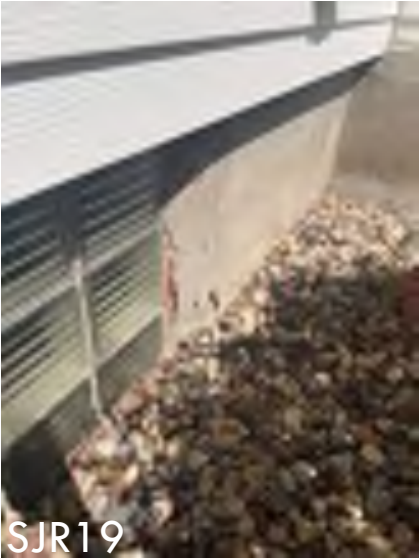
- SJR19 – Cracking at existing foundation. (various locations)
SJR20 – Downspout draining directly to foundation, reapply extension.
SJR21 – Significant rusting at garage door transition, door is peeling.
SJR22 – Siding is weathering in locations above overhangs.
SJR23 – Aluminum trim damaged at front entry.
SJR24 – Soffit missing in locations, existing wood is exposed.

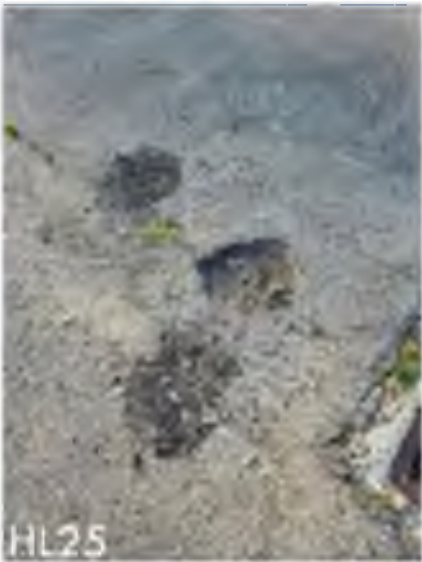
HL25 – Potholed asphalt near drainage structure.

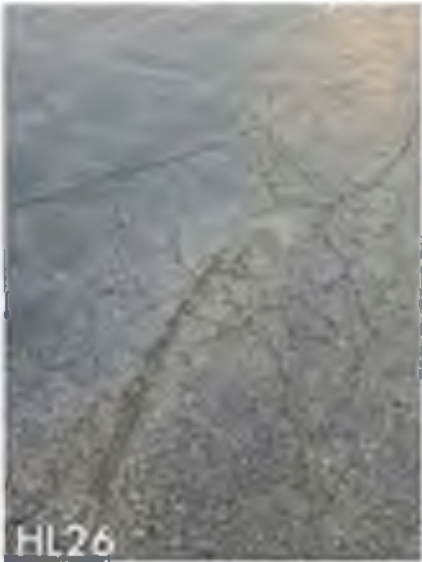
HL26 – Fatigue cracking in asphalt.

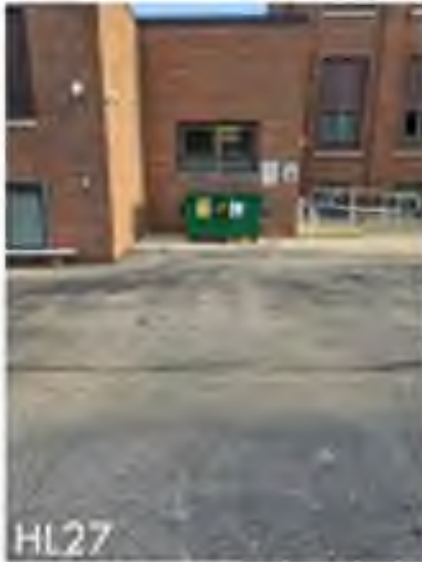
HL27 – Ruts in asphalt from garbage truck.

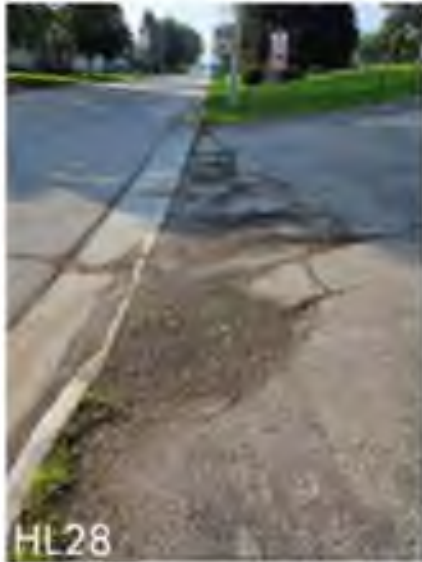
HL28 – Significant asphalt deterioration at east entry.

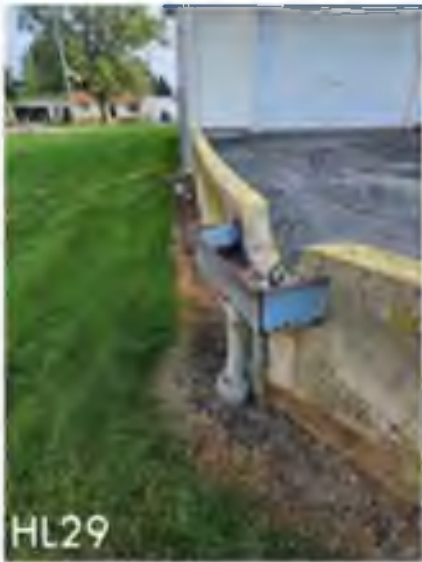
HL29 – Retaining wall at rectory driveway has full depth cracks and leaning.

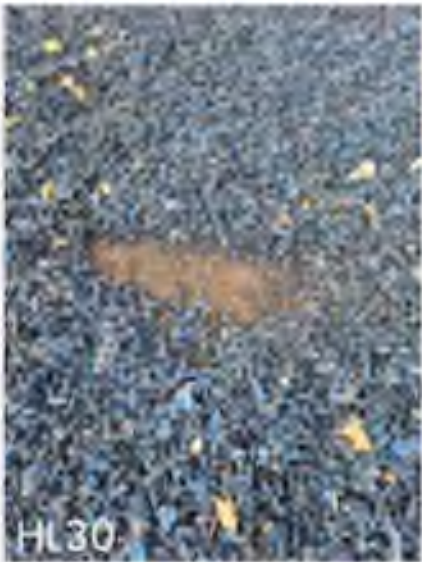
HL30 – Rubber mulch in playground completely worn to subgrade or at shallow depths.

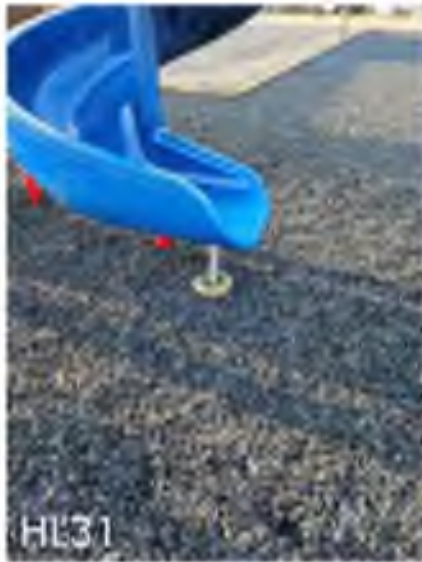
HL31 – Exposed playground equipment foundation.

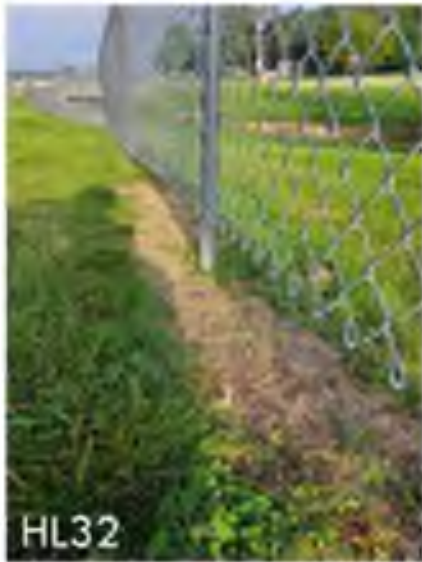
HL32 – Fence post and mesh height different creating large gap at bottom of fence system.

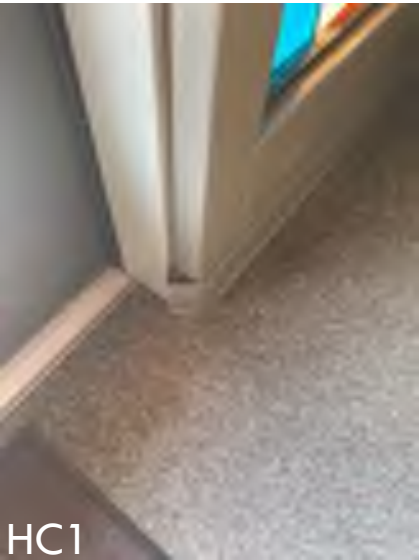
- HC1 - Vinyl base is separating from wall in entry locations.
- HC2 - Cracked caulking around window perimeter (various locations).
- HC3 - “Family”/Men’s restroom is not ADA, no ADA stall or proper grab bars are provided. ADA push clearance on door is not sufficient.
- HC4 - Women’s restroom has ADA clearance. Proper sink clearance & ADA stall is not provided.
- HC5/HC6 - Cracking seals and mildew buildup on stained glass.

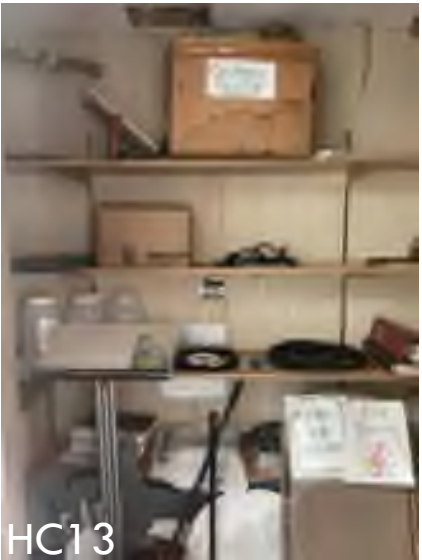
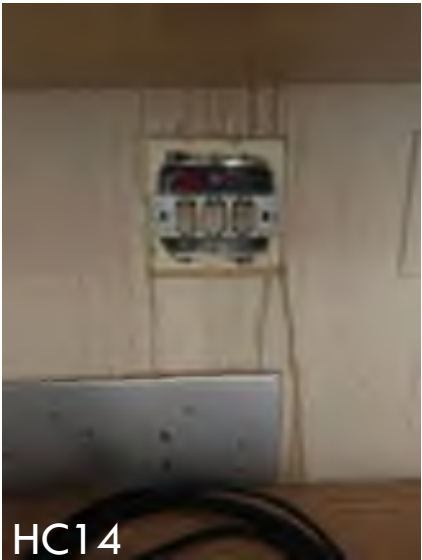
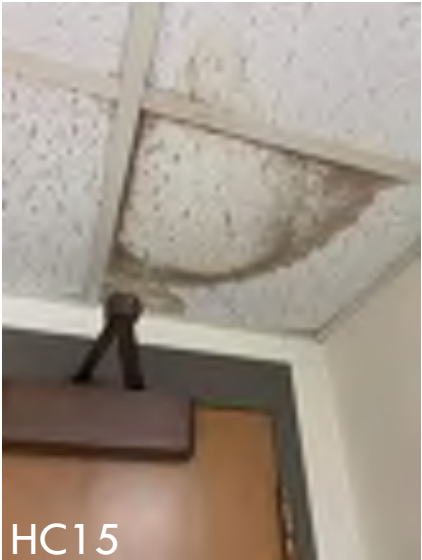
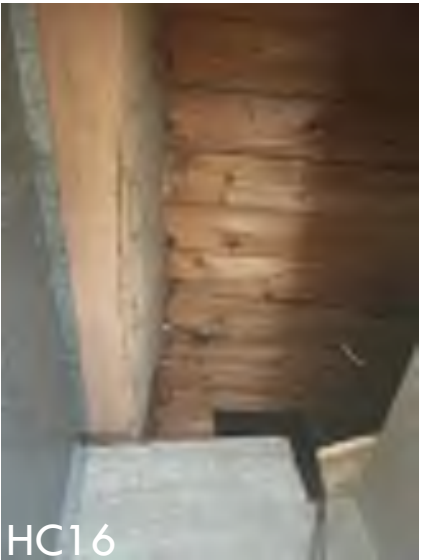
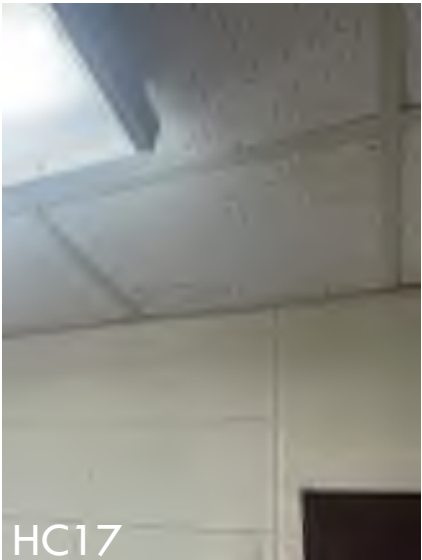
- HC13 - Staining along back closet wall.
- HC14 - Missing electrical faceplate along back closet wall.
- HC15 – Significant staining in ceiling tile.
- HC16- Staining on deck and structure above HC15. Leak did not look to be active.
- HC17 - Slight staining in corridor ceiling tile.

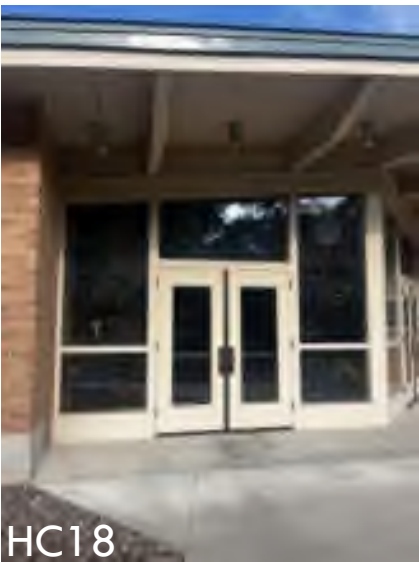
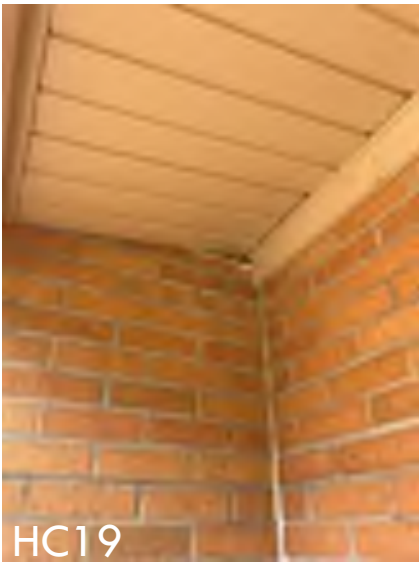
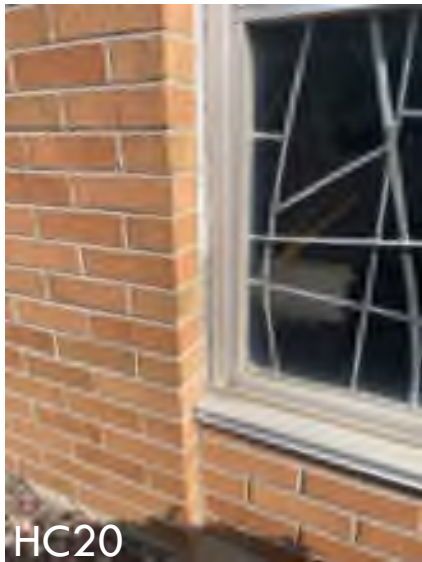
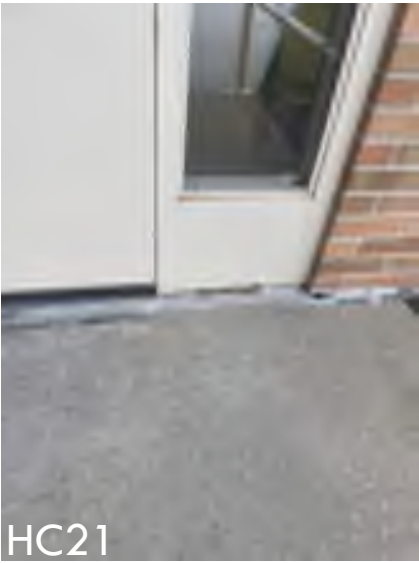
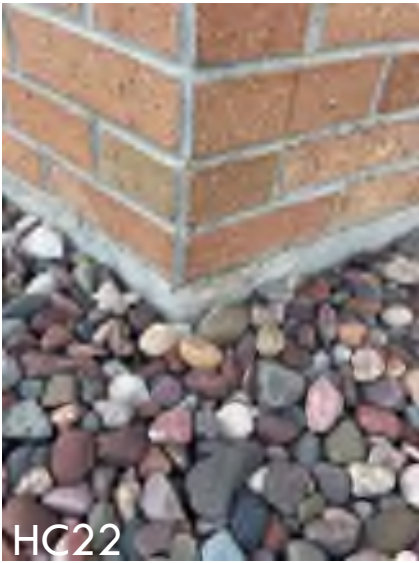
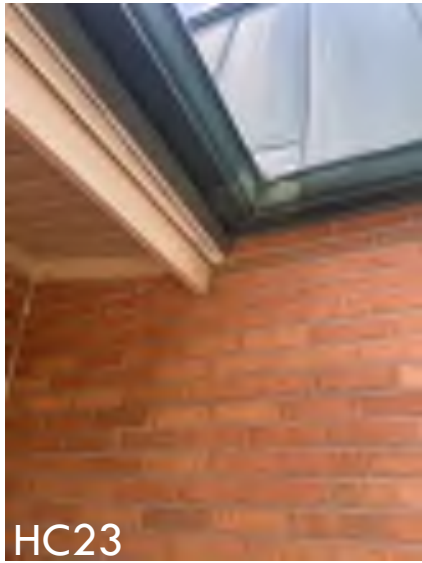
- HC18 – No exit device hardware at exterior/interior entries.
- HC19 - Gap at brick to soffit transition.
- HC20 - Cracking at exterior window sealant.
- HC21- Significant gap at door transition.
- HC22 - Foundation is overall is good shape, minimal cracking.
- HC23 - Caulking at gutter transition needs replacement.

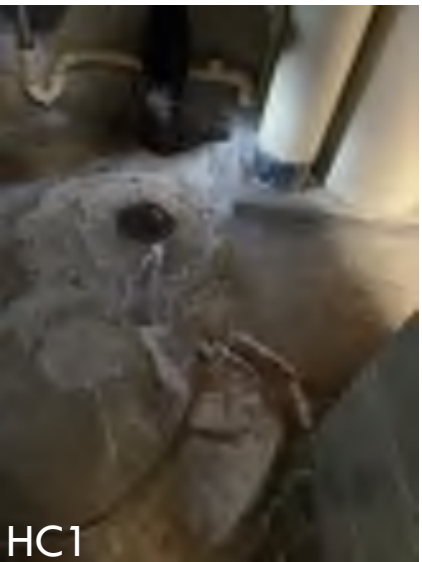
HC1

- HCR1 – Floor staining around drain, HVAC water pipe is not draining directly to the drain
- HCR2 – Conferencing space in lower level, not ADA accessible.
- HCR3 – Stair railing is not continuous.
- HCR4 – Cracking at exterior foundation wall.

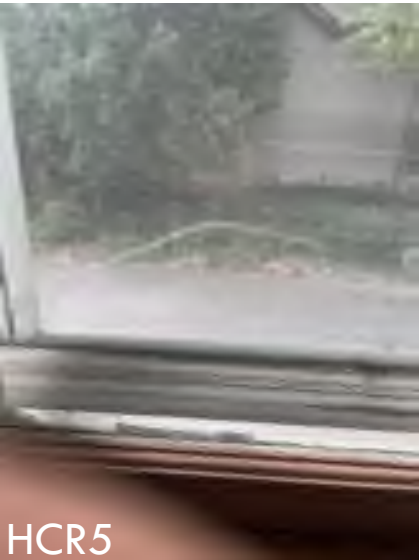
- HCR5 – Cracking in the storm window
- HCR6 – Restroom is not ADA compliant
- HCR7 – Copier is in tight location, does not have proper ventilation
- HCR8 – Kitchen is not ADA compliant
- HCR9 – No ADA access into the rectory
- HC10 – Windows are wood/vinyl single pane, may be near end of useful life.

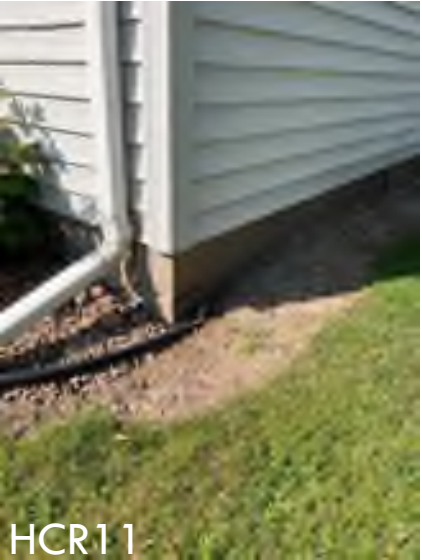
HCR11 – Vinyl siding in good condition, tuckpointing needed at CMU.
HCR12 – Single pane basement windows are peeling and may be past useful life.
HCR13 – Garage entry door is peeling at narrow lite window.
HCR14 – Garage CMU base is chipping at locations.

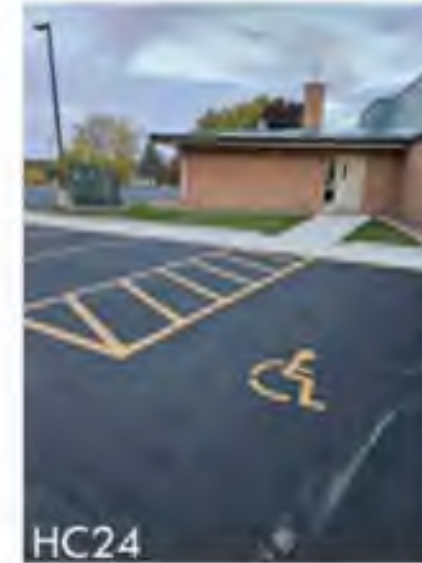
HC24 – Missing ADA post signs.

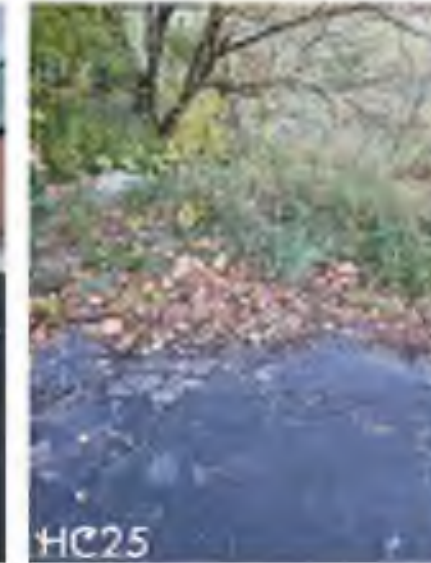
HC25 – Debris and pavement deterioration at asphalt low point. Drainage pipe clogged.

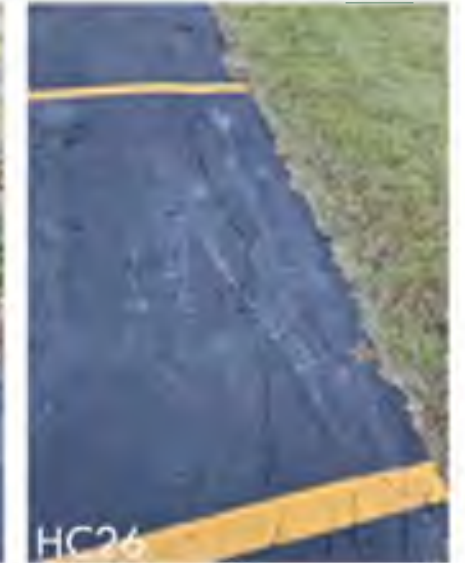
HC26 – Asphalt edge cracking and minor rutting from parking vehicles.

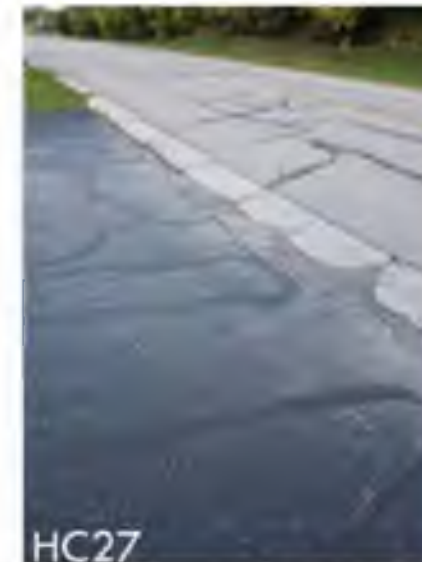
HC27 – Asphalt deterioration at north entrance.

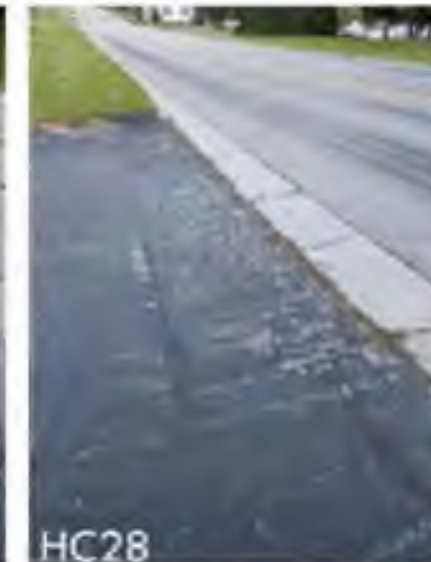
HC28 – Asphalt deterioration at northeast entrance.

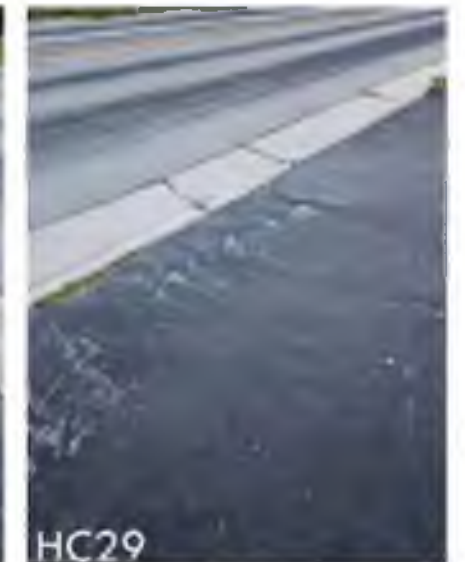
HC29 – Asphalt deterioration at southeast entrance.

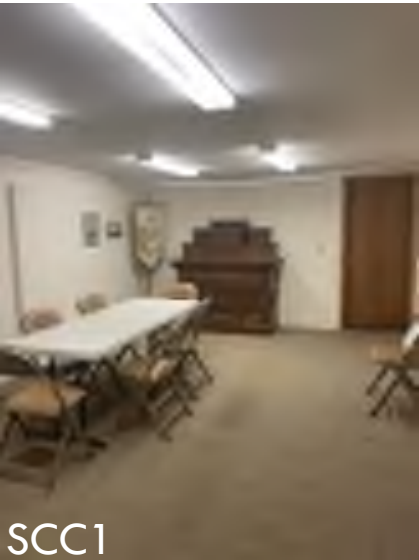
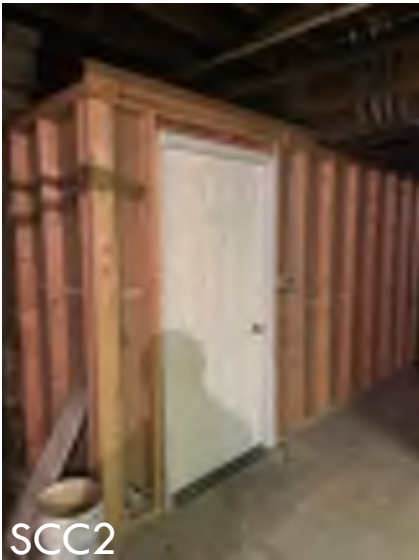
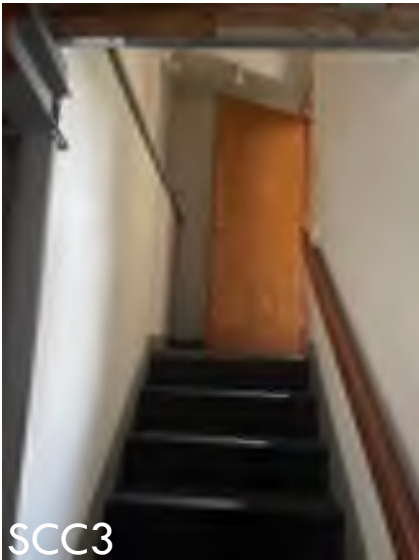
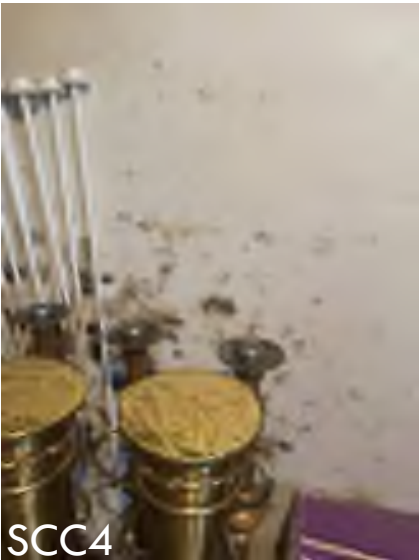
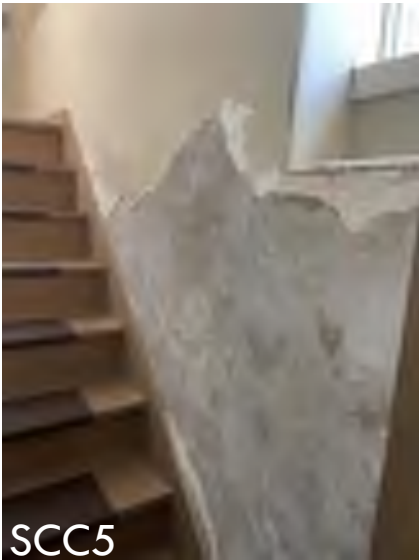
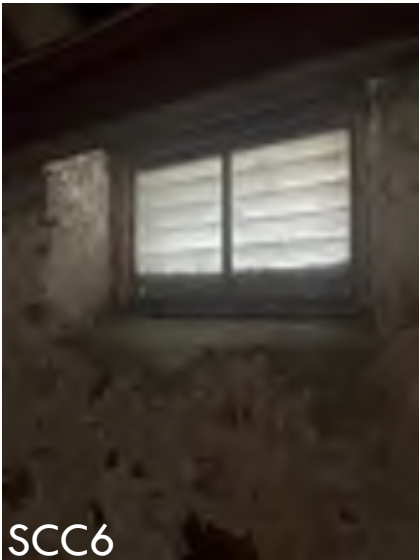
- SCC1 – Gathering/Meeting space in basement, exit signs are at exit and two exits are provided, no ADA accessibility. (Not a code requirement)
- SCC2 – Mechanical room has rated door, walls are not of rated construction.
- SCC3 – ADA access is not provided to the lower level.
- SCC4 – Burn marks appear to be on the wall near stored candles.
- SCC5 – Plaster is chipping at exterior foundation wall.
- SCC6 – Caulking needed at some exterior windows.

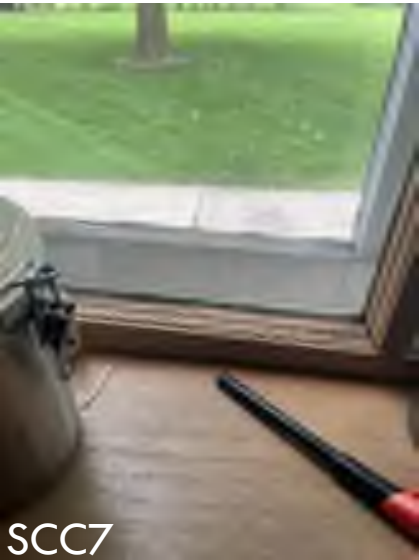
- SCC7 – Cracking in the glass of single pane wood window.
- SCC8 – Chipping/cracking at stained glass window jambs
- SCC9 – Exit sign is provided above egress door, sign is not illuminated
- SCC10 – ADA ramp is not provided at sanctuary, not a code issue but something to note for elderly congregation members.
- SCC11 – Salt/staining at tile floor
- SCC12 – Restroom is not ADA compliant.

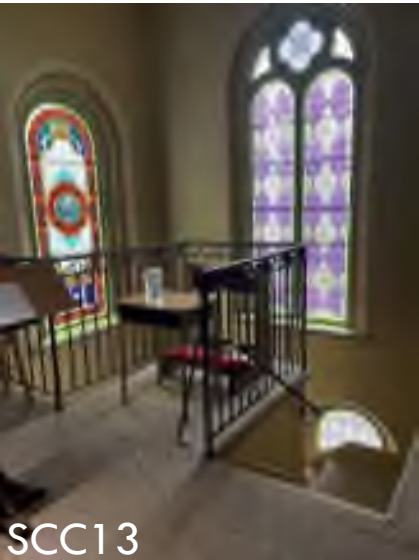
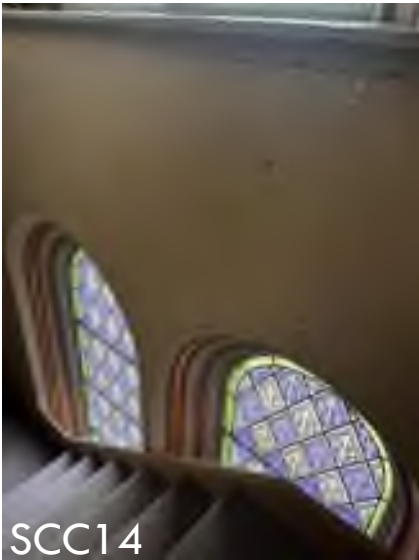
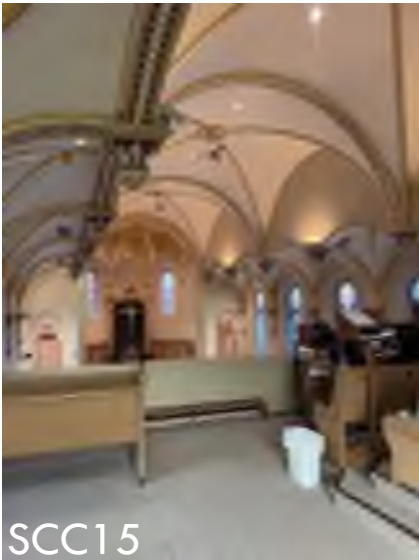
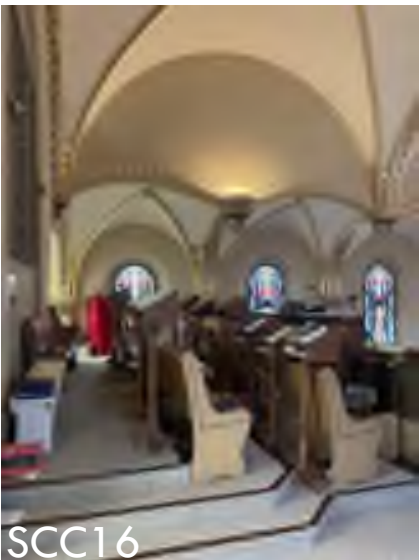
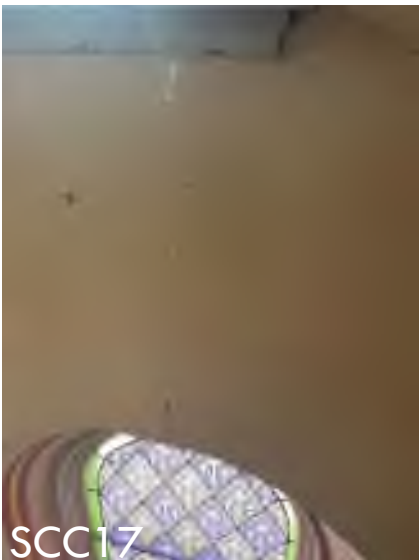
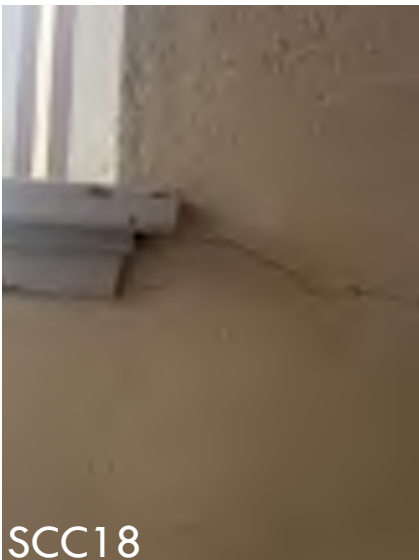
SCC13 & SCC14 – Railing only provided at one side of stair
SCC15 – Guardrail is not code compliant
SCC16 – Mezzanine Occupancy is limited to 29, current provided seats may be higher than allowed occupancy.
SCC17 & SCC18– Cracking at window sills

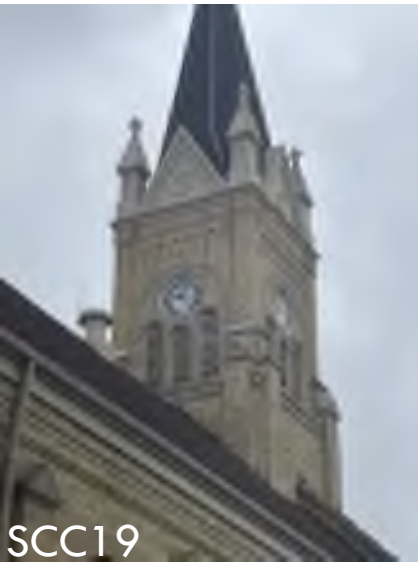
SCC19 – Large areas of masonry at belltower need tuckpointing.
