OUR LADY OF THE HOLYLAND PARISH

EXISTING FACILITIES CONDITIONS REPORT

DECEMBER 1, 2023

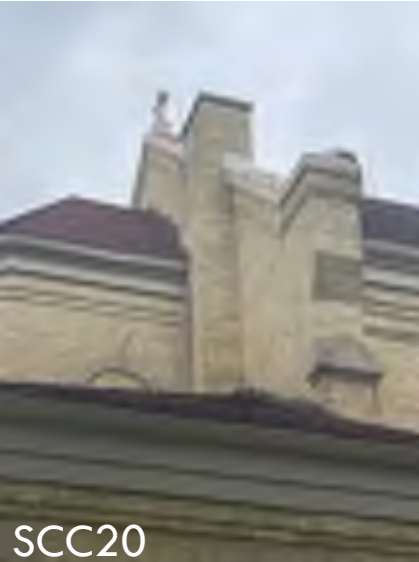
SCC20 – Metal coping is rusting at locations.

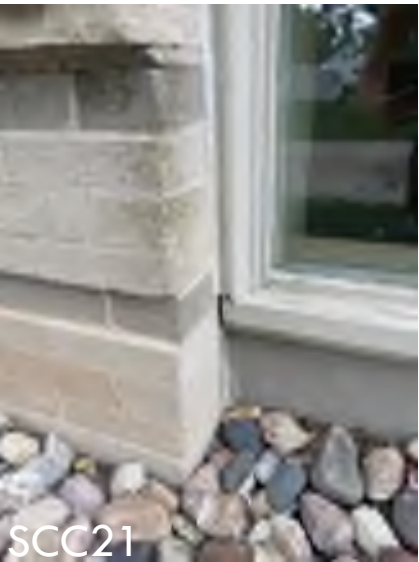
SCC21 – Wood trim at lower windows is gapping at locations.

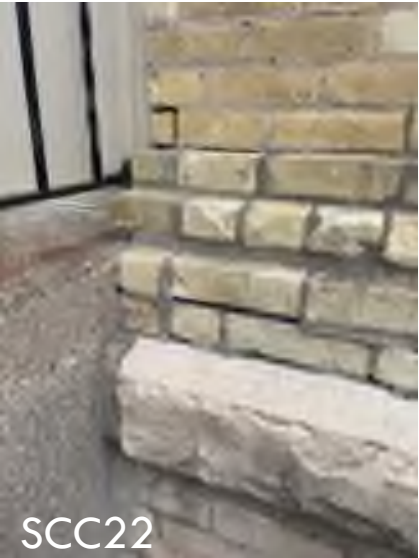
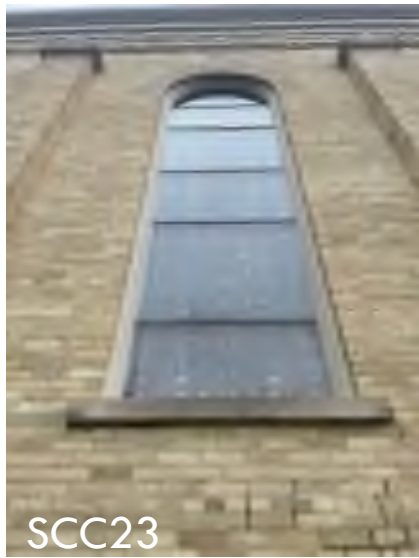
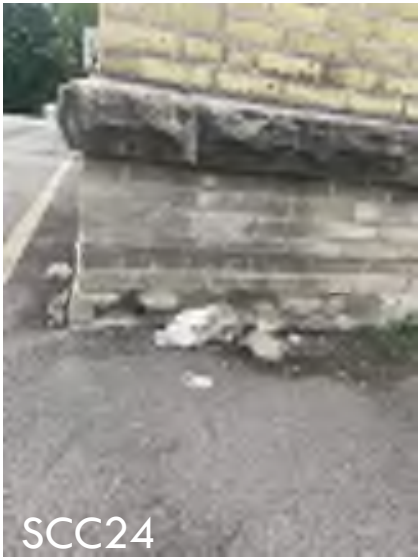
SCC22 – Tuckpointing at lower brick in various locations, some loose bricks are on the ground.

SCC23 – Storm windows are cracked in some locations.

SCC24 – Loose stone is on the ground at the base.

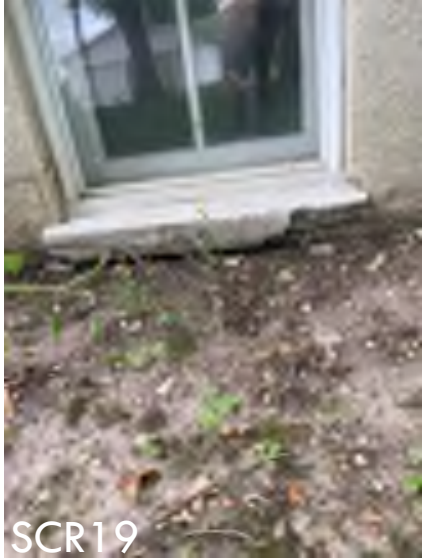
- SCR19 – Chipping at concrete window sill.
- SCR20 – Door threshold is weathered and rotted.
- SCR21 – Gap at underside of soffit.
- SCR22 – Exposed wood decking at roof, open penetration.
- SCR23 – Peeling at basement windows.
- SCR24 – Peeling/cracking at concrete transition.

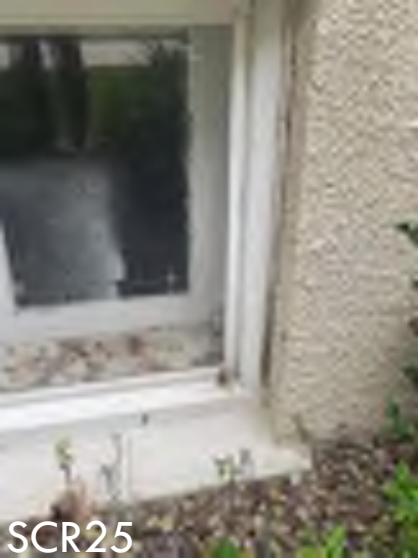
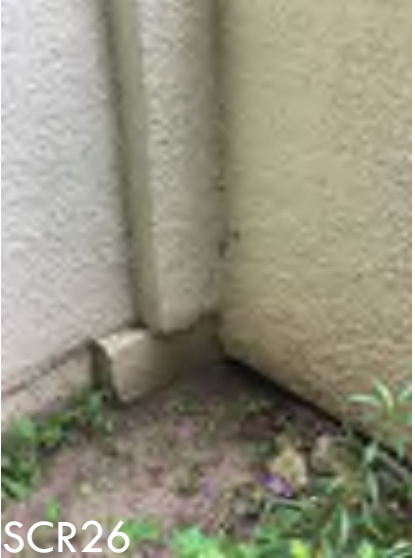
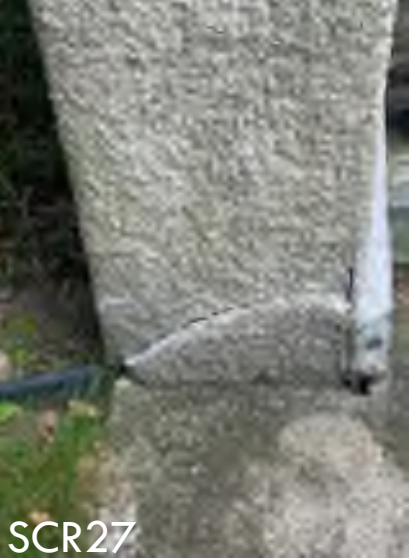
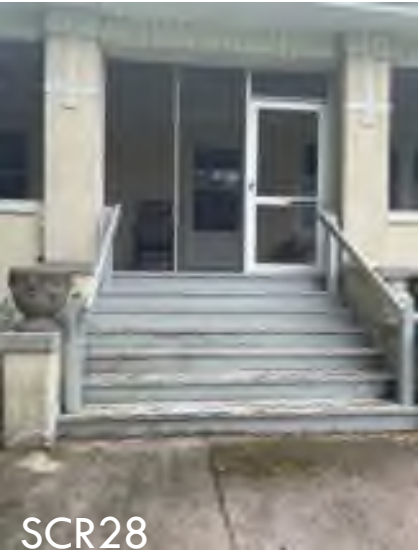
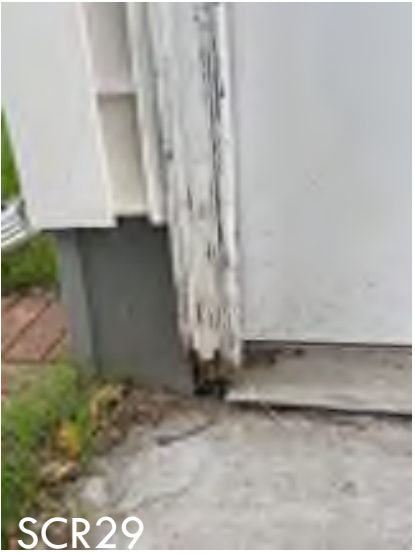
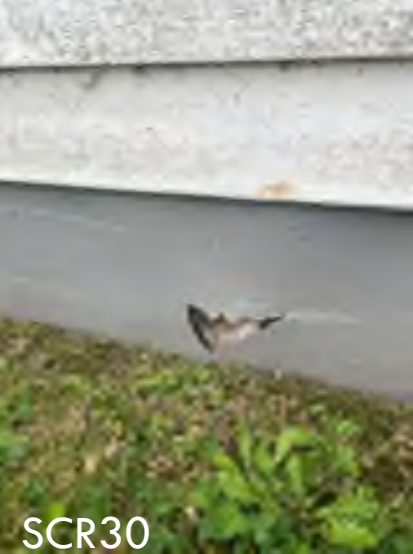
- SCR25 – Broken glass at storm window,
- SCR26 – Cracking at corner transition.
- SCR27 – Misalignment & cracking at foundation.
- SCR28 – Peeling/weathering at entry stair. Door swing overlaps with railing.
- SCR29 – Rotting/peeling at garage trim.
- SCR30 – Holes in siding and FRP at garage.

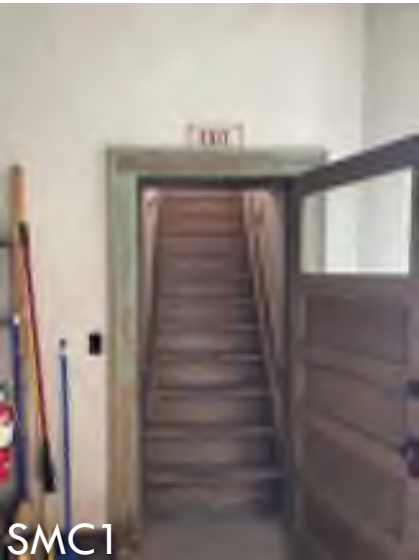
SMC1 – Stair is not code compliant, exit is not in appropriate location, exit sign does not lead to exterior.

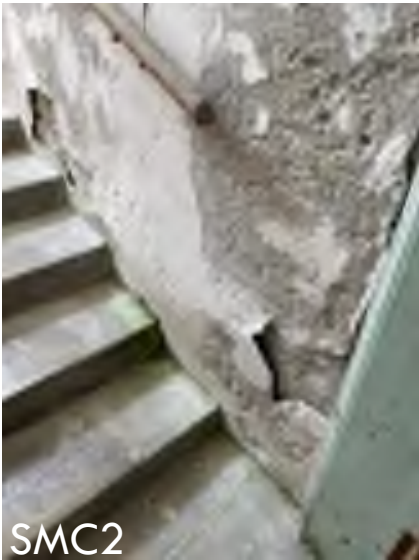
SMC2 – Cracking/peeling at exterior foundation wall.

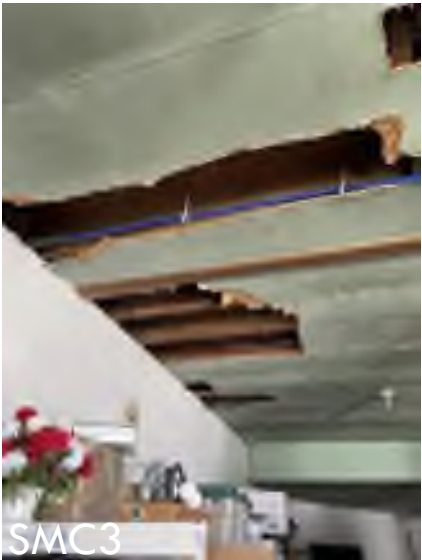
SMC3 – Missing ceiling/water damage at ceiling.

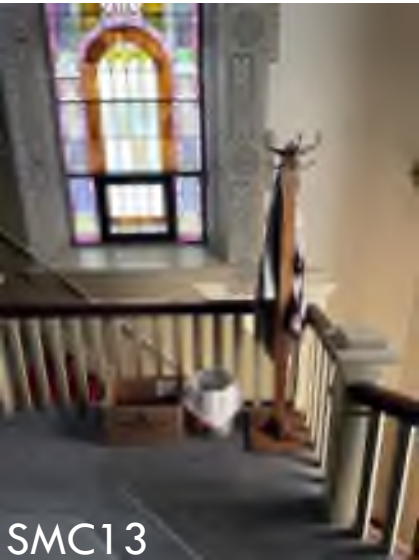
SMC13 – Railing only provided at one side of stair, guardrail is not code compliant.

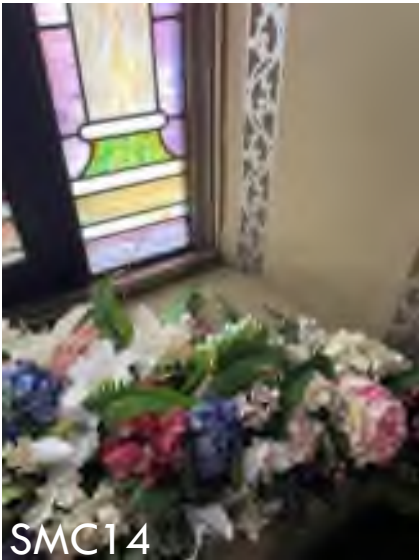
SMC14 – Mildew forming at stained glassing, wood chipping at jambs

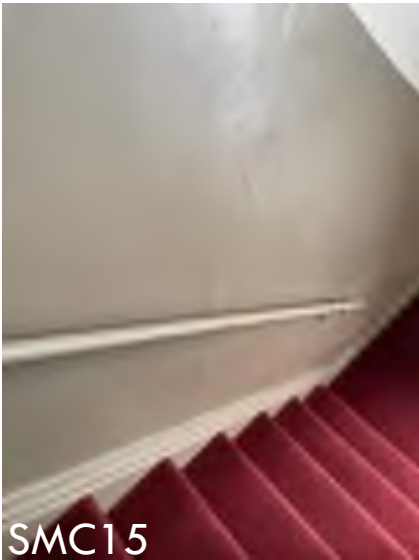
SMC15 – Cracking at plaster wall.

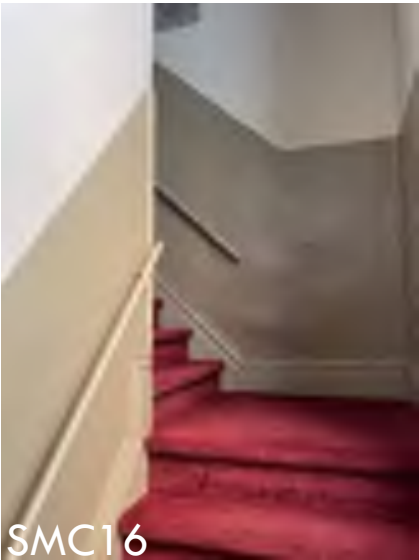
SMC16 – Railing extensions are not code compliant.

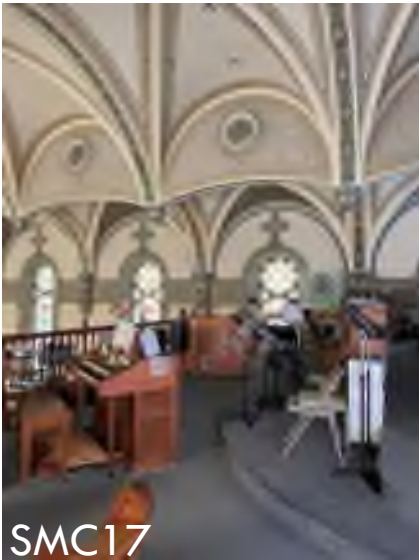
SMC17 – Mezzanine Occupancy is limited to 29, current provided seats may be higher than allowed occupancy.

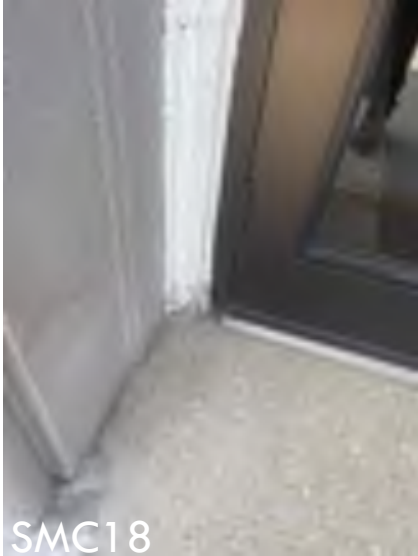
- SMC18 – Peeling Paint/Rotting wood at door jamb.
- SMC19 – Sealant around the door is starting to gap.
- SMC20 – Rotted wood at stained glass window storms.
- SMC21 & SMC22 – Minor tuckpointing needed at base masonry.
- SMC23 – Cracking vinyl siding & loose weatherstripping at vestibule.

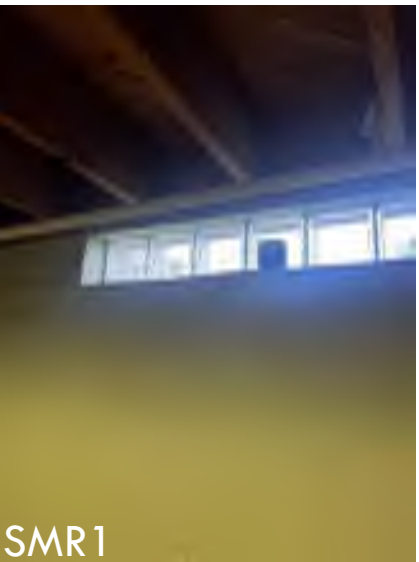
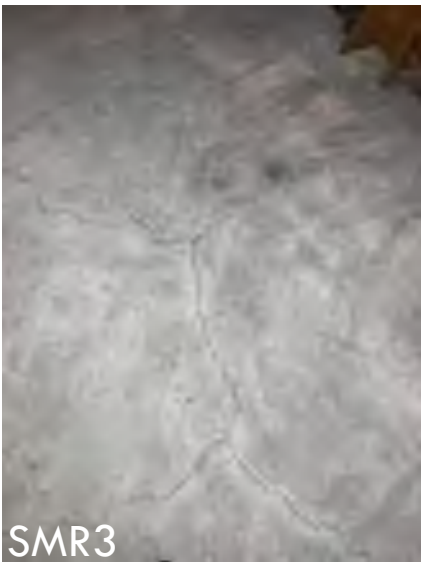
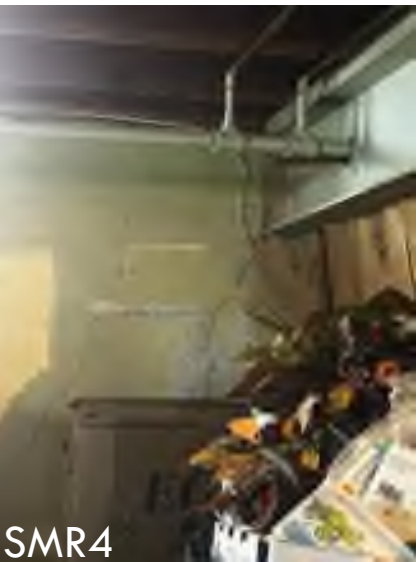
SMR1 & SMR2 – Cracking at exterior foundation wall

SMR3 – Cracking at concrete floor

SMR4 – Significant cracking where steel beam is bearing on foundation wall. This condition should be further evaluated for water penetration and structural integrity of wall

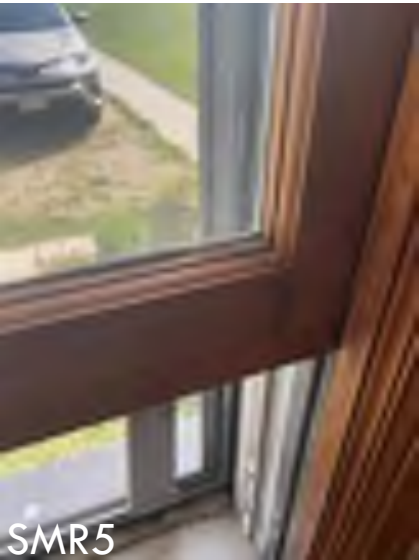
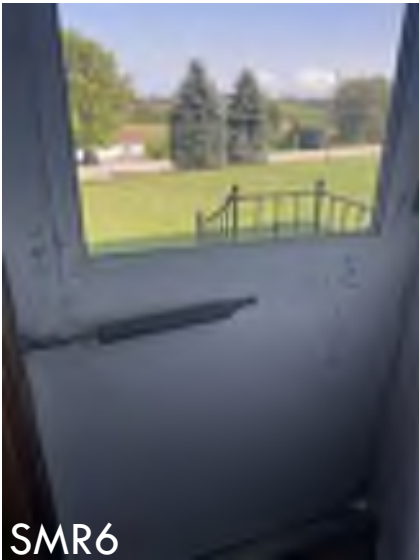
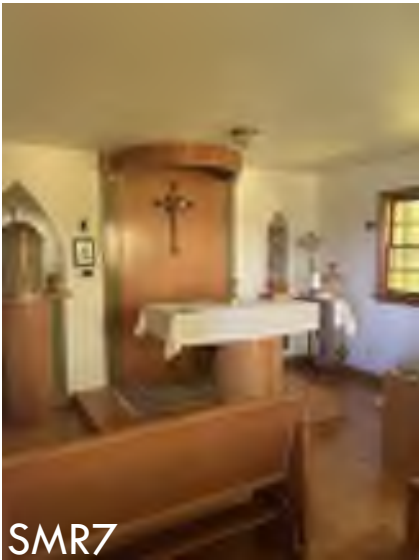
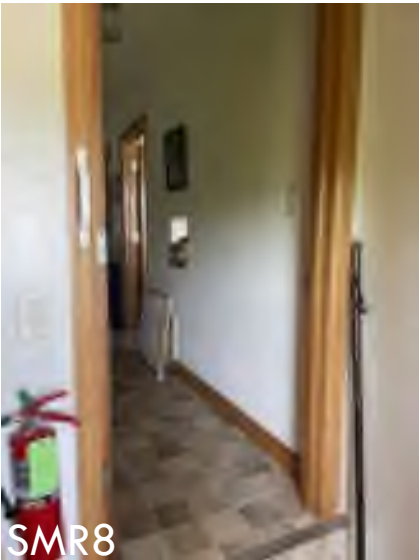
SMR5 – Windows are original to building, water damage noted at some locations, seals are popping, resident noted draftiness in the winter.
SMR6 – Storm door has significant peeling/cracking at interior side.
SMR7 – Assembly occupancy in residential building.
SMR8 – No ADA accessibility is provided to the building.

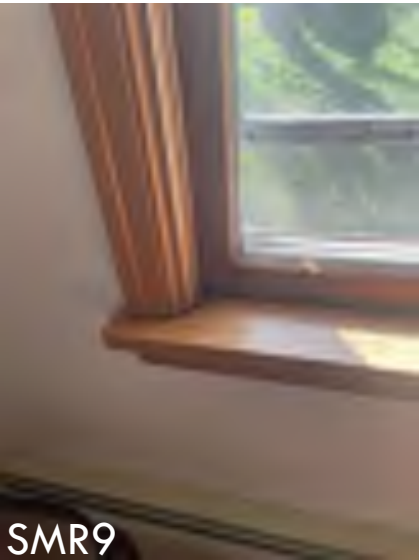
SMR9 – Windows are original to building, water damage noted at some locations, seals are popping, resident noted draftiness in the winter.

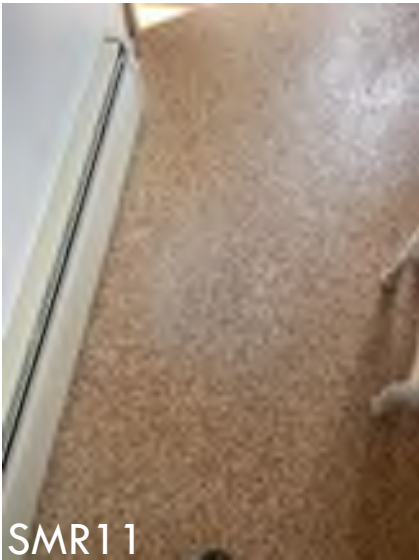
SMR11 – Hallway flooring is starting to wear in locations.

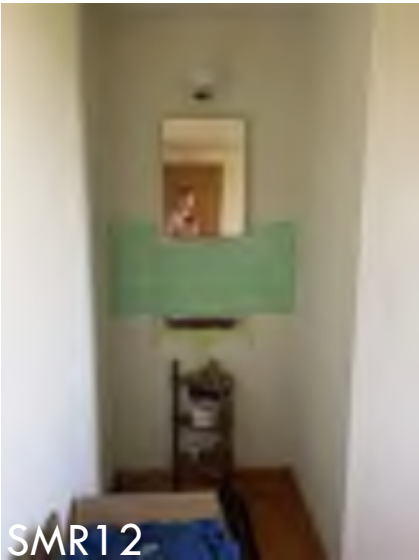
SMR12 – Metal wall mounted hanger for sink is exposed, consider removal and patching.

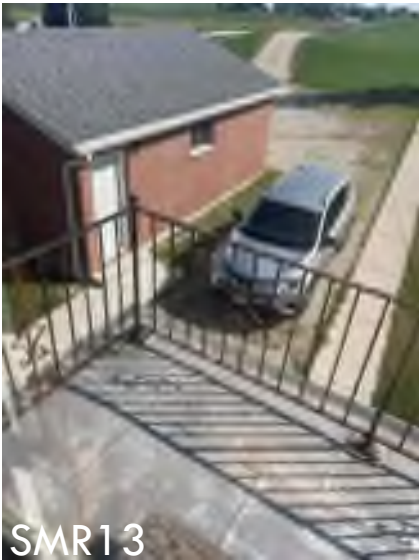
SMR13 – Patio membrane is gapping in locations, railing is starting to rust.

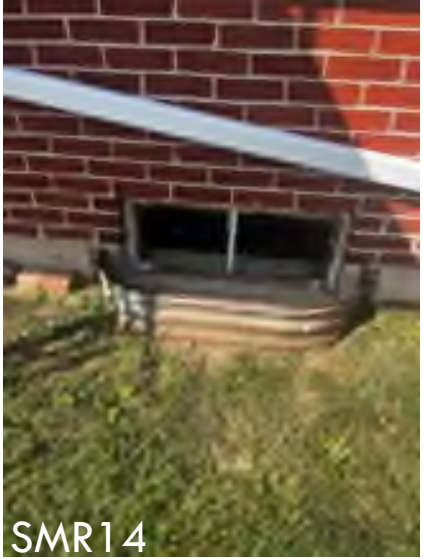
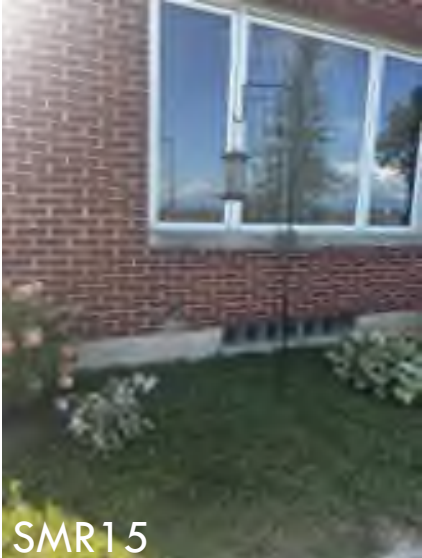
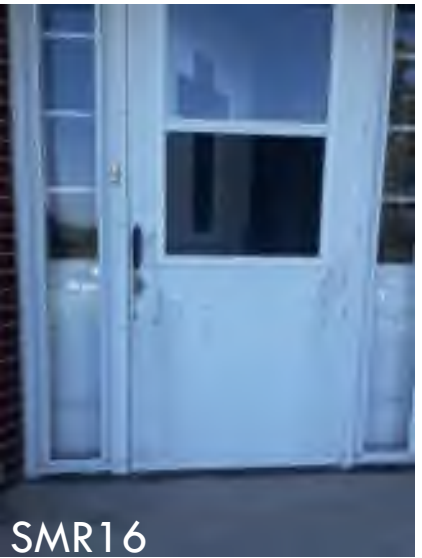
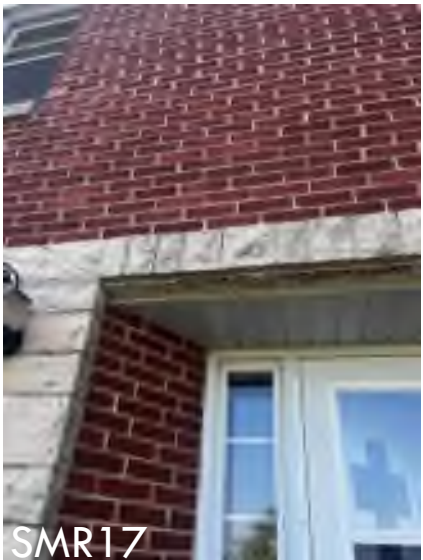
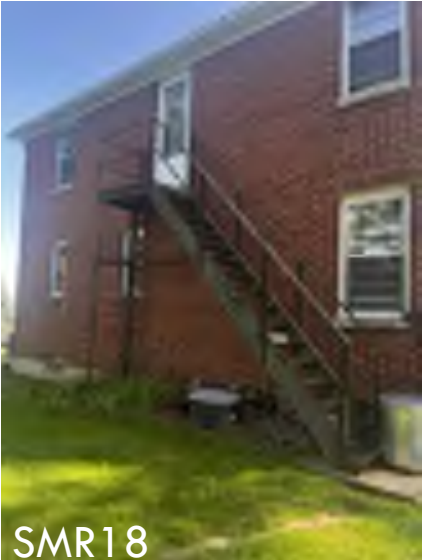
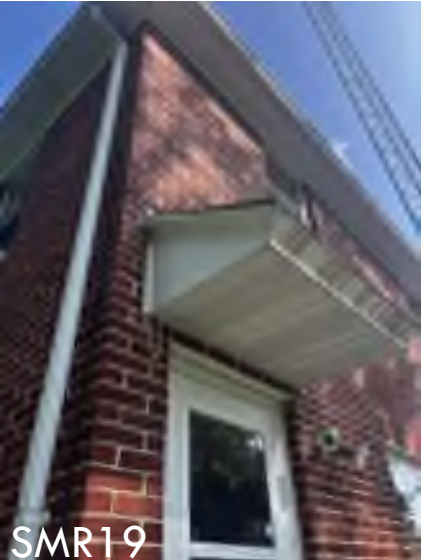
- SMR14 – Rusting at basement windows.
- SMR15 – Efflorescence in various locations.
- SMR16 – Storm door has significant peeling/cracking at exterior side.
- SMR17 – Exterior header needs is rusting and will need prep & painting.
- SMR18 – Exterior stair railings are not code compliant.
- SMR19 – Rusting at overhang fascia.

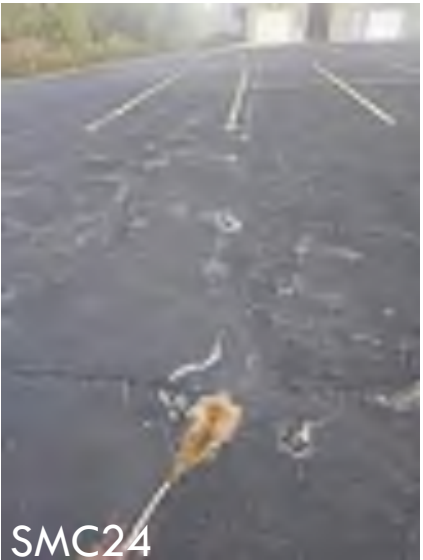
SMC24 – Deep, depressed cracks with the start of fatigue cracking.

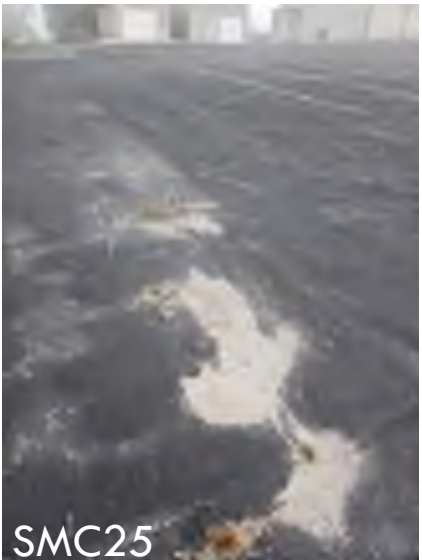
SMC25 – Sediment accumulation which signifies standing water.

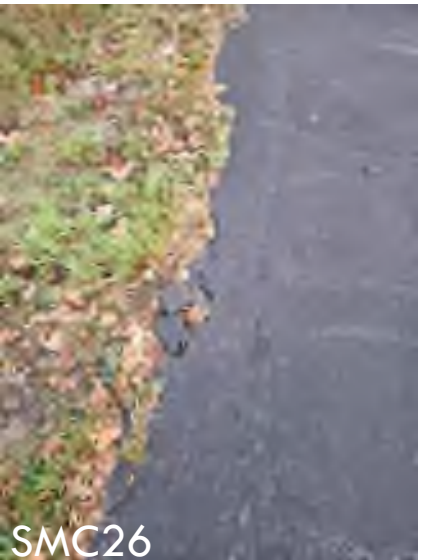
SMC26 – Asphalt edge cracking and minor rutting from parking vehicles.

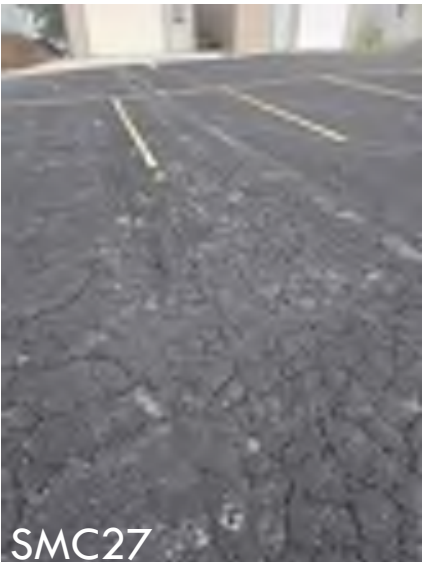
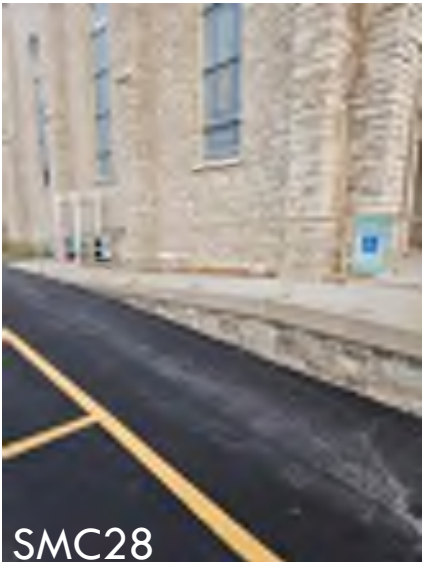
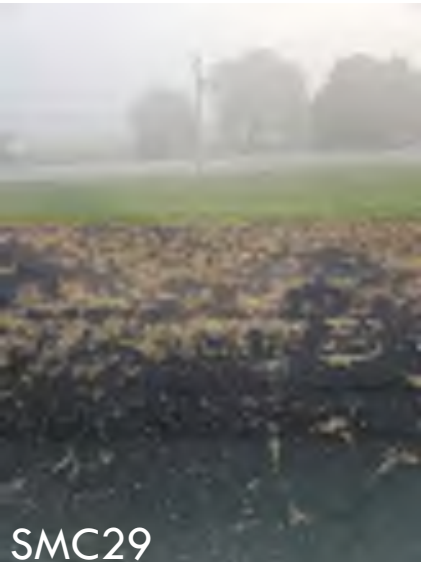
SMC27 – Significant fatigue cracking.

SMC28 – ADA signs installed too low.

SMC29 – Significant fatigue cracking and vegetation intrusion.

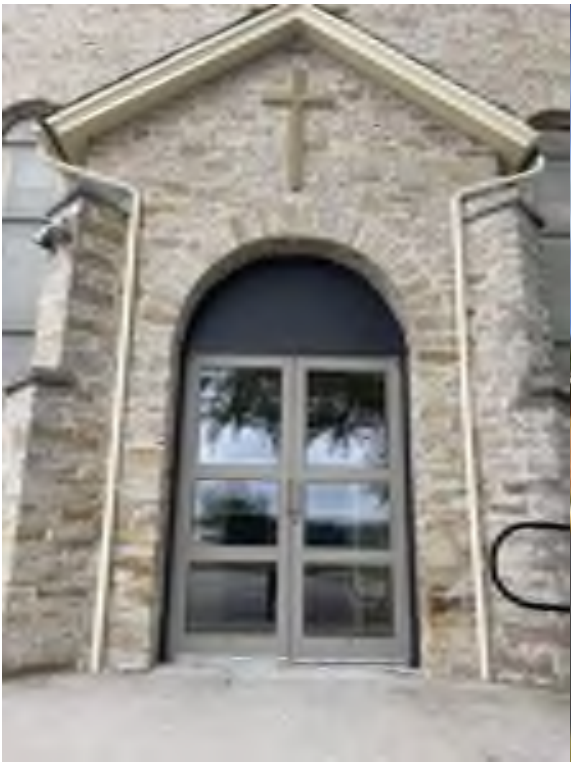
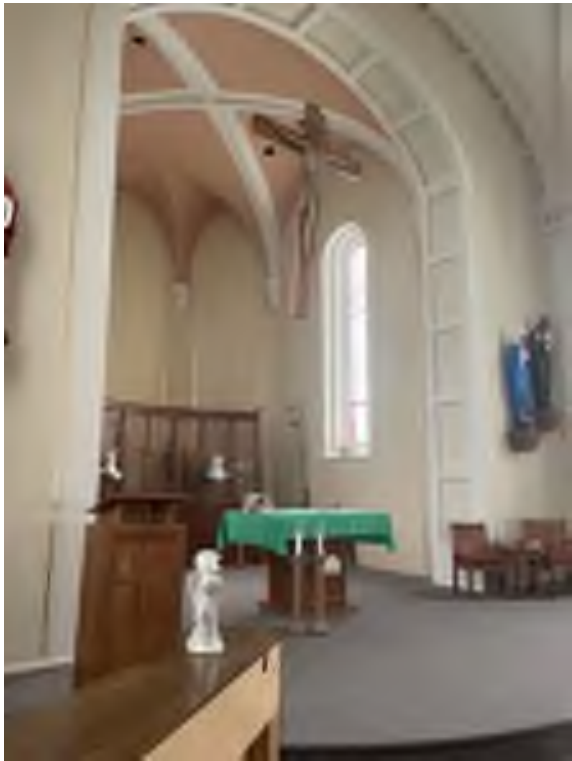
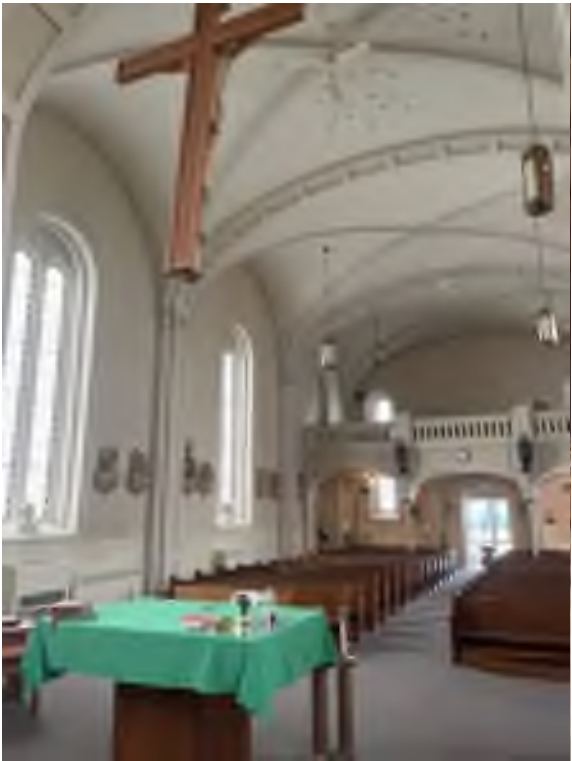
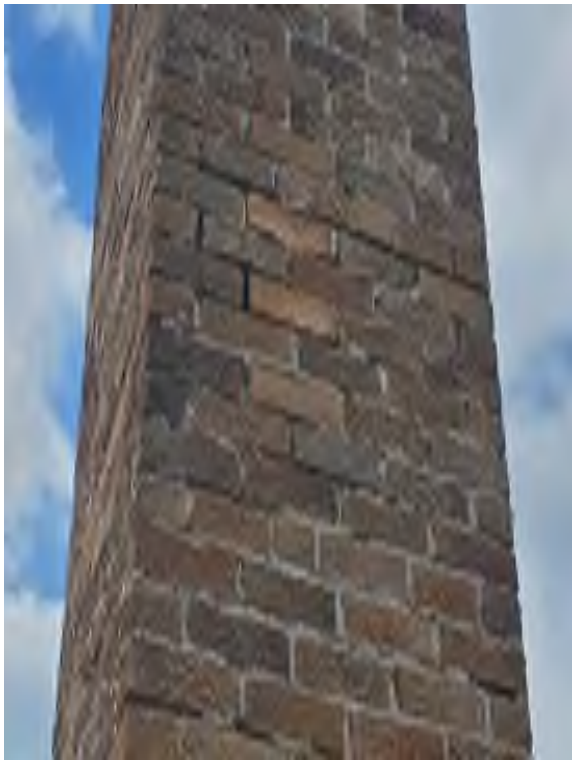
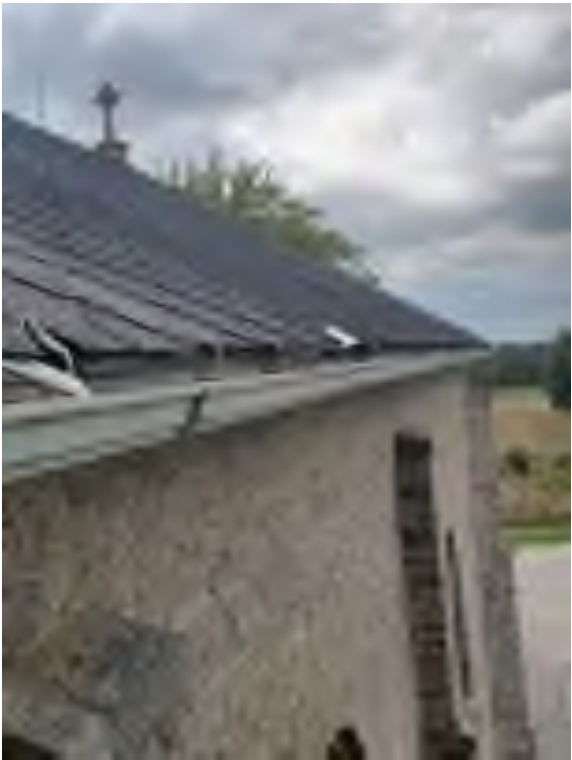
ROOF AGE:	Unknown (Original)
ROOF TYPE:	Slate Tile (Assumed Asbestos)
CONDITION:	Moderate
RECENT REPAIRS:	None Noted
RECOMMENDED REPAIRS:	Broken/loose tiles at eave, deteriorated mortar at chimney, loose gutter straps.
REMAINING LIFE:	3-5 Years

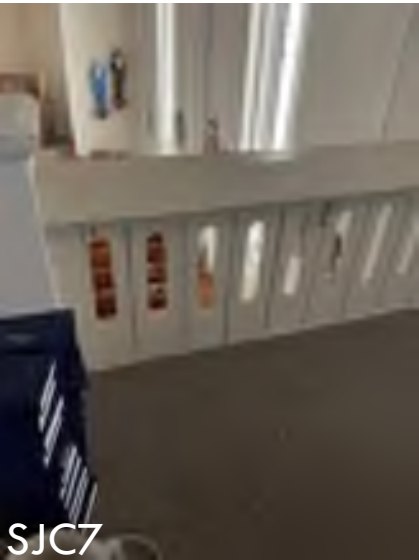
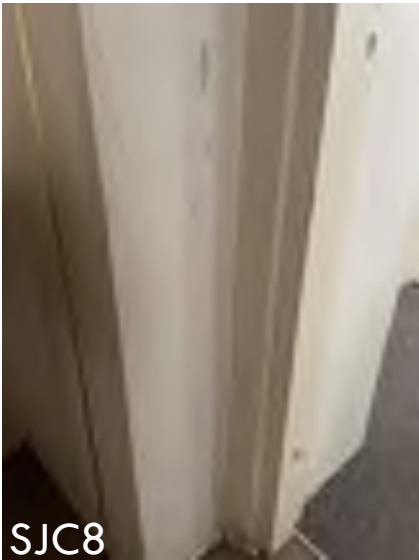
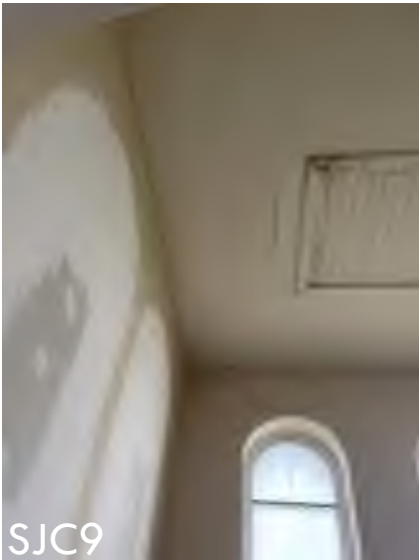
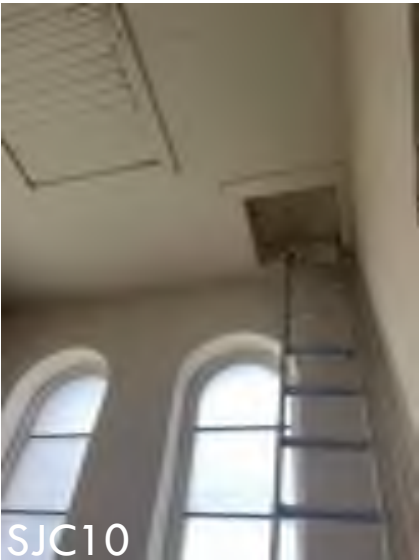
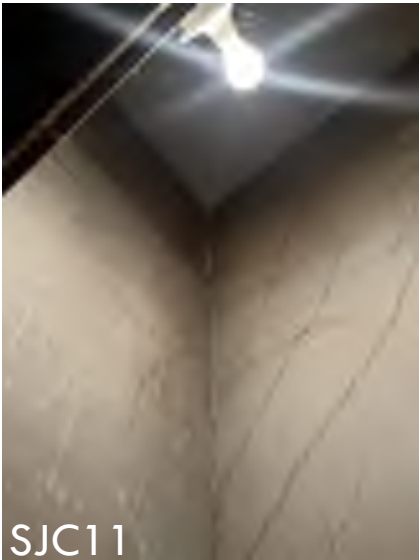
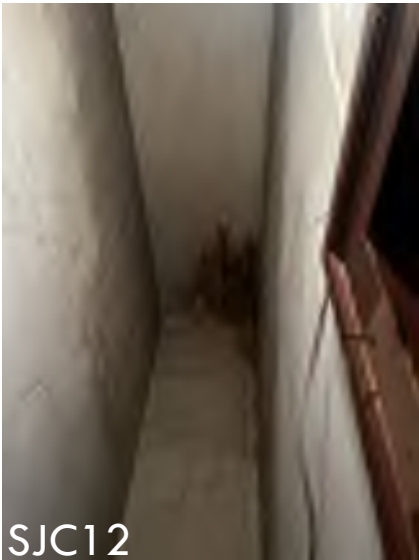
- SJC7 – Railing is not code compliant.
- SJC8 – Cracking at existing plaster.
- SJC9 – Windows were removed and infilled, paint needed at locations.
- SJC10 – Ladder is exposed, suggest storing or marking off with a chain when not in use.
- SJC11 – Significant cracking in plaster at storage mezzanine.
- SJC12 – Significant water damage at storage mezzanine.

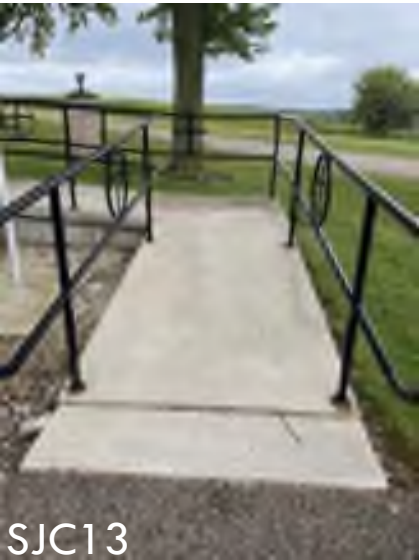
SJC13 – Transition from surface parking to lot is raised, leveling this transition should be considered.

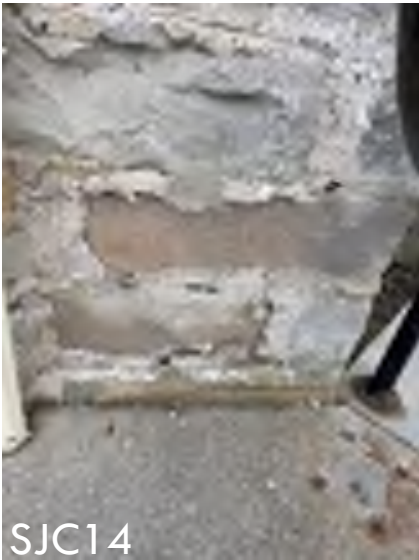
SJC14 – Minor areas of masonry repair and tuckpointing needed.

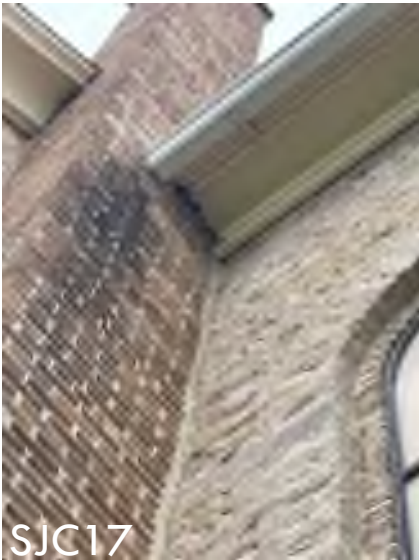
SJC17 – Gaps/Rotting at fascia transition

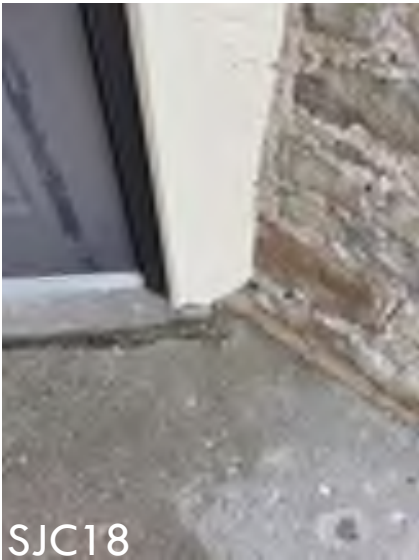
SJC18 – Gapping at door jamb, consider caulking any open transitions.

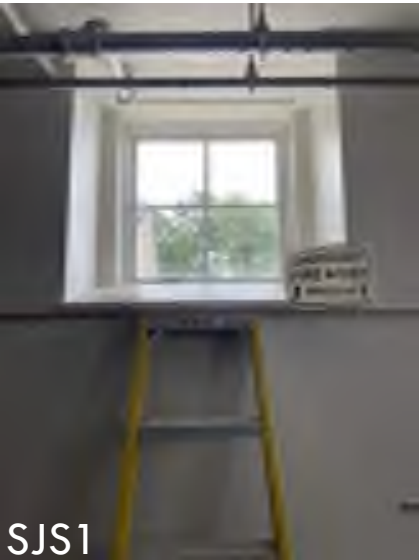
SJS1 – Classroom space is not code compliant, 2 exits are not present. Ladder and window are not code compliant.

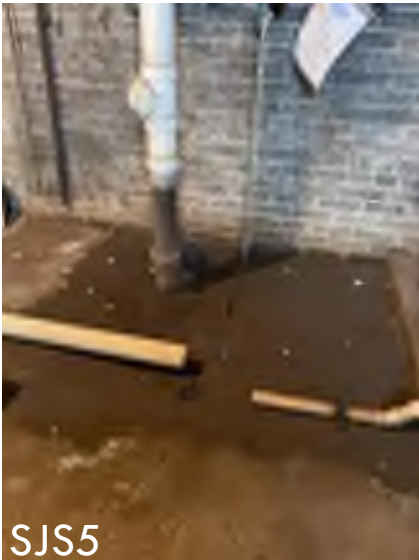
SJS5 – Dampness around piping in mechanical room

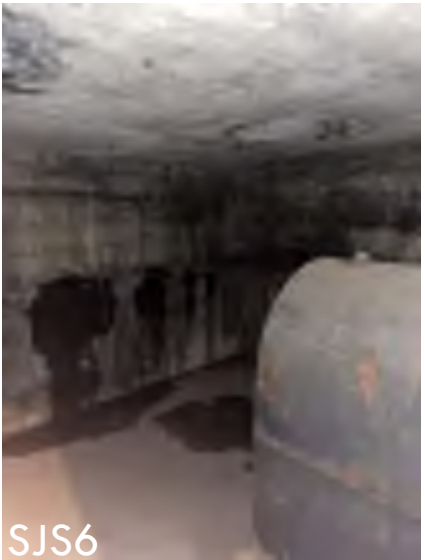
SJS6 – Significant wet spots at boiler room.

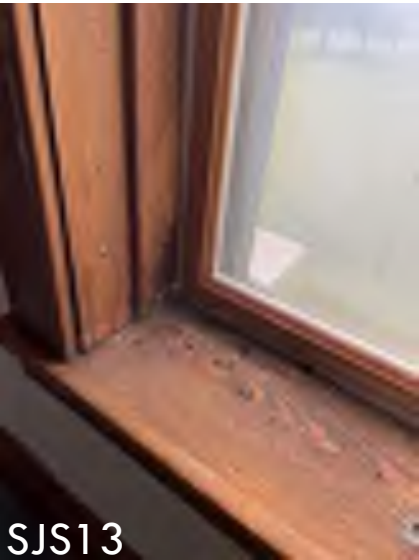
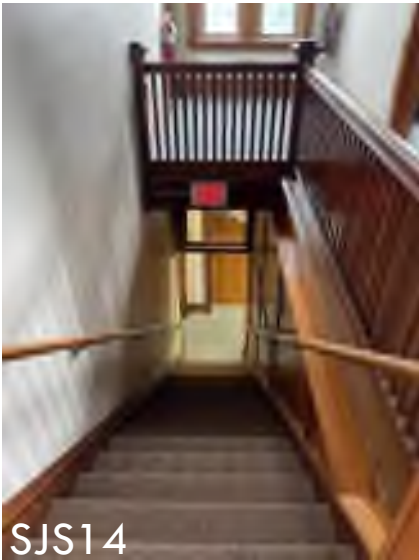
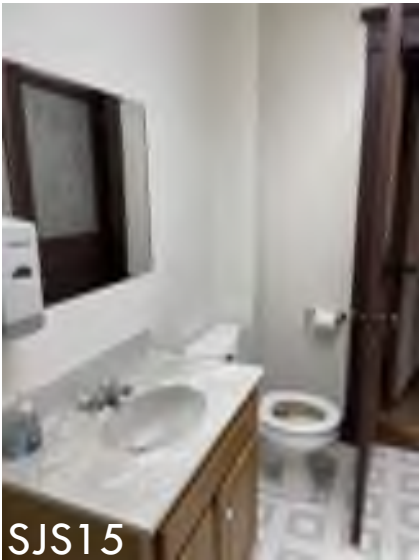
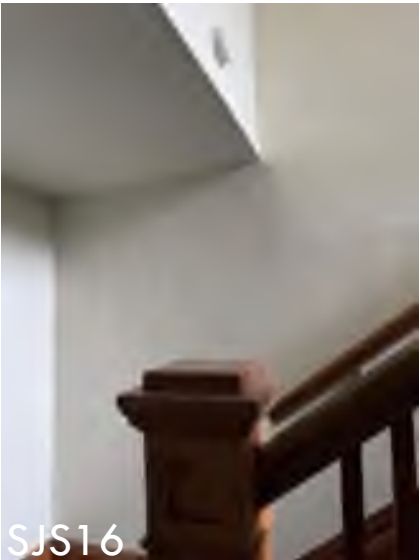
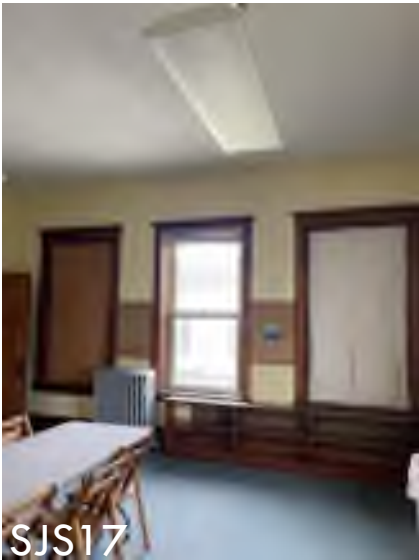
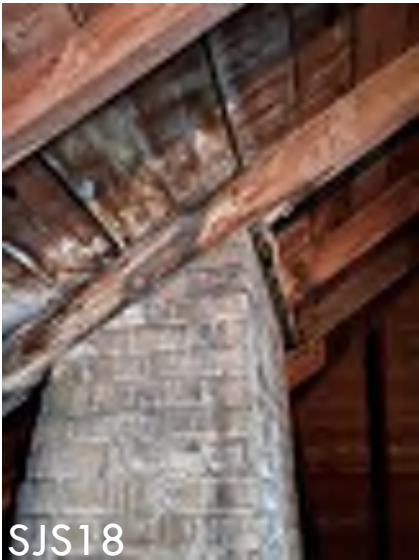
- SJS13 – Some exterior windows need replacement, some are new.
SJS14 – Stair is higher than allowed by code without a mid-landing.
SJS15 – Toilet rooms are not accessible, staining is present in the fixtures.
SJS16 – Mid-landing ceiling at main stair is lower than allowed by code.
SJS17 –Exposed plywood at infilled windows.
SJS18 – Significant rotting at chimney. Consider removal. Localized roof deck and rafter replacement needed.

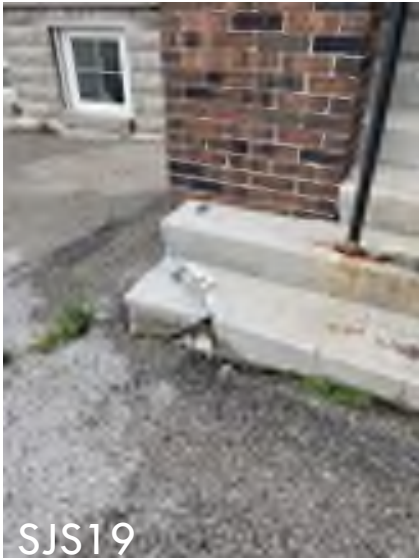
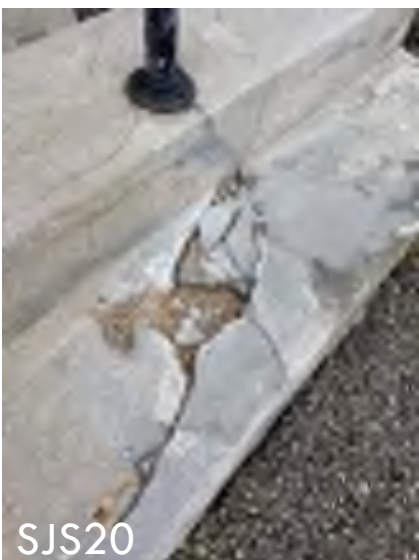
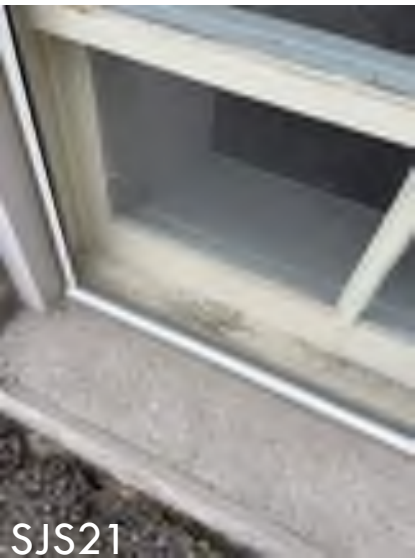
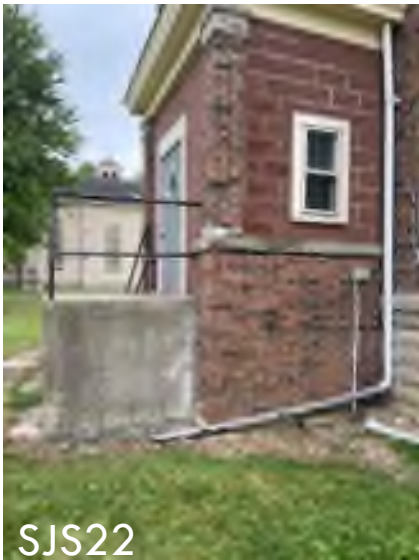
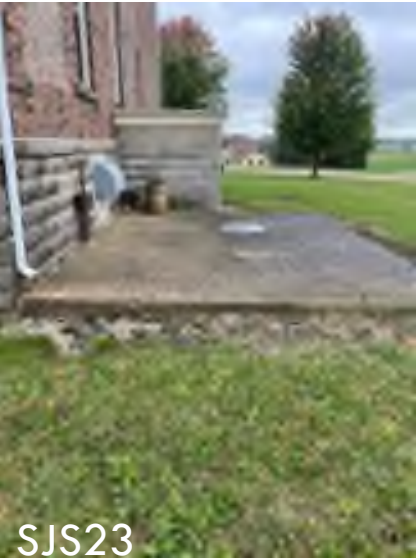
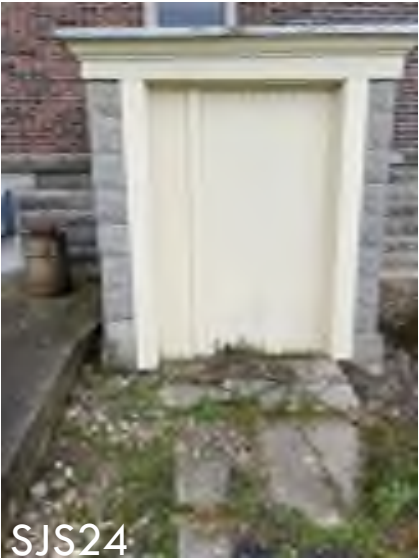
- SJS19 & SJS20 – Significant cracking on the exterior stair.
- SJS21 – Basement windows consist of some new and some original to the building, may be past their useful life.
- SJS22 – Vestibule needs tuckpointing at CMU and brick, generally the building needs tuckpointing.
- SJS23 –Exterior condition of photo SJS6.
- SJS24 – Rotting at some of the exterior wood.

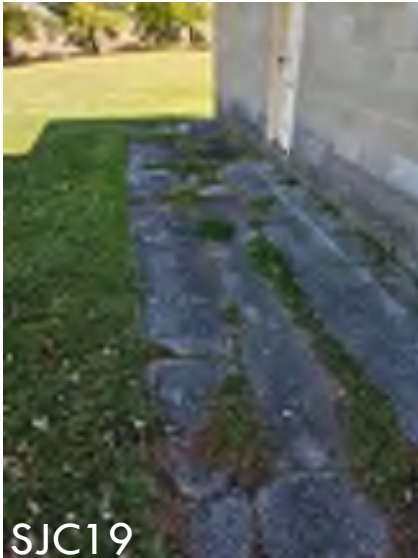
- SJC19 – Significantly deteriorated concrete drainage channel.
- SJC20 – Significant cracking and rutting on cemetery access road.
- SJC21 – Depressions and fatigue cracking.
- SJC22 – Faded parking stall striping.
